# Access Compliance Report

## Public Rights-of-Way

### (Curb Ramps)

| Intersection ID: 47979 | Main Street: SPRINGS_MILL_RD | Cross Street: RAFFIA_RD | Location: NE |

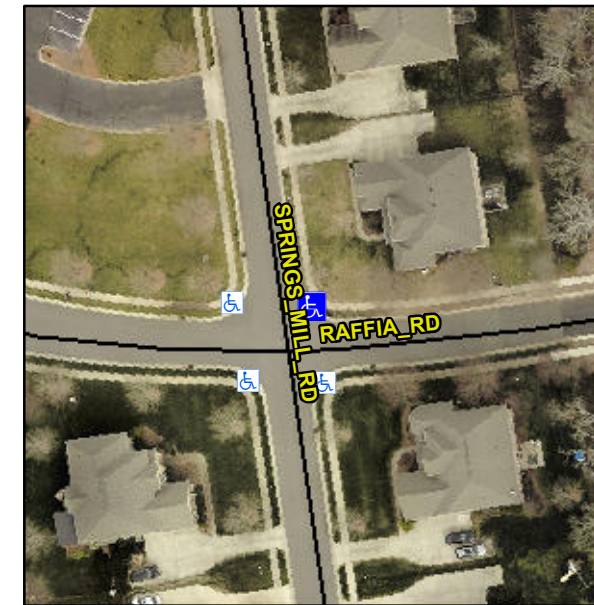
| ADA ID: 70FC6365F67D | Ramp Type: PerpDiag | Initial Pass/Fail: Pass | Overall Compliance: No |
| | | Severity Score: 5.25 | |

**Not Found, R304.5.3, R304.2.1, R304.2.2-Perp, R304.3.2-Para, R305.2, R304.5.4**

| Compliance | Description | Data | Compliance | Description | Data |
|---|---|---|---|---|---|
| Yes | Ramp Width (in) | 48.0 | No | Ramp XSlope (%) | 3.8 |
| No | Landing Length (in) | 46.0 | Yes | DWS Provided? | Yes |
| No | Landing Slope (%) | 4.3 | Yes | DWS Length (in) | 24.0 |
| No | Landing X Slope (%) | 3.5 | Yes | DWS Full Width? | Yes |
| N/A | Landing Curb? (Y/N) | No | No | DWS Offset (in) | 6.0 |
| Yes | Gutter Ponding? | No | No | Gutter Slope (%) | 6.4 |
| Yes | Gutter Lip Ht (in) | 0.0 | No | Gutter X Slope (%) | 6.0 |

**Remove & Replace Curb Ramp With Two New Directional Ramps or Equivalent. Remove & Replace Gutter.**
