Access Compliance Report

Public Rights-of-Way

(Curb Ramps)

Intersection ID: 27847	Main Street: PARADISE RIDGE RD	Cross Street: NORTH COMMUNITY HOUSE RD	Location: NE
ADA ID: 710BC0173651	Ramp Type: ParaDiag	Initial Pass/Fail: Fail	Overall Compliance: No
Codes/Mitigation Info/Possible Solution		Field Measurements/Component Compliance	
Severity Score: 13.75

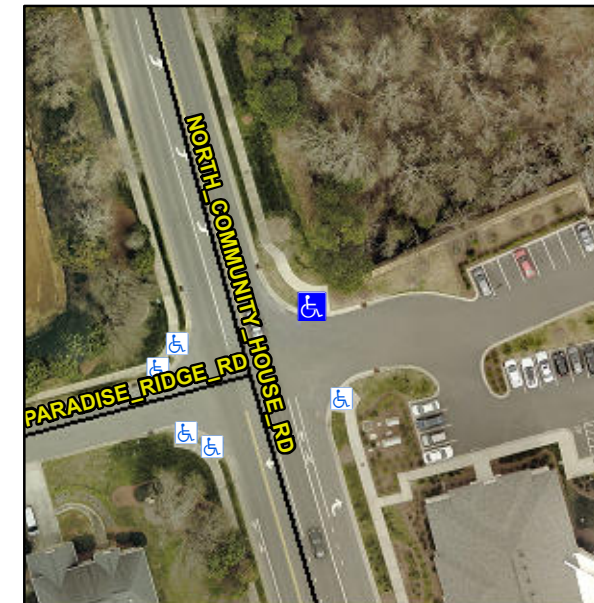
LT RP < 5%

Compliance	Description	Data	Compliance	Description	Data
N/A	Ramp Length LT (in)	28.0	N/A	Ramp Length RT (in)	50.0
Yes	Ramp Width LT (in)	167.0	Yes	Ramp Width RT (in)	167.0
Yes	Ramp Slope LT (%)	0.1	No	Ramp Slope RT (%)	11.1
Yes	Ramp XSlope LT (%)	1.9	No	Ramp XSlope RT (%)	2.7
N/A	Landing Length (in)	N/A	N/A	DWS Provided?	N/A
N/A	Landing Width (in)	N/A	N/A	DWS Contrast?	N/A
N/A	Landing Slope (%)	N/A	N/A	DWS Length (in)	N/A
N/A	Landing X Slope (%)	N/A	N/A	DWS Full Width?	N/A
N/A	Landing Curb? (Y/N)	N/A	N/A	DWS Offset (in)	N/A
N/A	Shared Landing?	N/A			
N/A	Gutter Ponding?	N/A	N/A	Gutter Slope (%)	N/A
N/A	Gutter Lip Ht (in)	N/A	N/A	Gutter X Slope (%)	N/A
N/A	Painted X Walk1?	No	N/A	Painted X Walk2?	No
	X Walk 1 Direction	To SW		X Walk 2 Direction	To SE
N/A	X Walk 1 Width (in)	N/A	N/A	X Walk 2 Width (in)	N/A
	X Walk 1 Slope (%)	2.7		X Walk 2 Slope (%)	1.5
	X Walk 1 X Slope (%)	2.3		X Walk 2 X Slope (%)	4.6
N/A	Ramp inside XWalk1?	N/A	N/A	Ramp inside XWalk2?	N/A

Road Slope (%)	5.3	N/A	Clear Space?	N/A
	Road X Slope (%)	0.9	N/A	Clear Space to XWalk (in)	N/A
N/A	Any Obstructions?	N/A	N/A	Storm Grate/Utility Hazard?	N/A
	Obstruction Type			Storm Grate/Utility Type	
		N/A			N/A
			Yes	Surface Condition? (G/P)	Good
			N/A	Curb Slope (%)	2.1

Possible Solutions:

Remove & Replace Curb Ramp With Two New Directional Ramps or Equivalent.

PROW/ADA:

R304.3.2, R304.5.3
