Access Compliance Report

Public Rights-of-Way (Curb Ramps)

Intersection ID: 2500	Main Street: CAMBRIDGE_BAY_DR	Cross Street: VISCOUNT_LN	Location: SE
ADA ID: 7112D08922ED	Ramp Type: PerpDiag	Initial Pass/Fail: Fail	Overall Compliance: No
Codes/Mitigation Info/Possible Solution		Field Measurements/Component Compliance	
Severity Score: 10

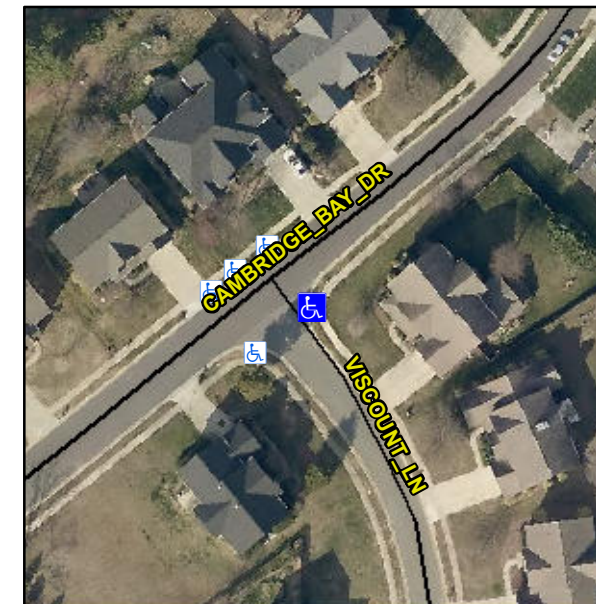
Not Found, R304.5.1, R304.5.3

Compliance	Description	Data	Compliance	Description	Data
N/A	Ramp Length (in)	47.0	Yes	Ramp Slope (%)	6.8
No	Ramp Width (in)	36.0	No	Ramp XSlope (%)	2.5
N/A	Flare Type LT	N/A	N/A	Flare Type RT	N/A
N/A	Flare Slope LT (%)	N/A	N/A	Flare Slope RT (%)	N/A
N/A	Flare Traversable LT?	N/A	N/A	Flare Traversable RT?	N/A
N/A	Landing Length (in)	N/A	N/A	DWS Provided?	N/A
N/A	Landing Width (in)	N/A	N/A	DWS Contrast?	N/A
N/A	Landing Slope (%)	N/A	N/A	DWS Length (in)	N/A
N/A	Landing X Slope (%)	N/A	N/A	DWS Full Width?	N/A
N/A	Landing Curb? (Y/N)	N/A	N/A	DWS Offset (in)	N/A
N/A	Shared Landing?	N/A			
N/A	Gutter Ponding?	N/A	N/A	Gutter Slope (%)	N/A
N/A	Gutter Lip Ht (in)	N/A	N/A	Gutter X Slope (%)	N/A
N/A	Painted X Walk1?	No	N/A	Painted X Walk2?	No
	X Walk 1 Direction	To NW		X Walk 2 Direction	To SW
N/A	X Walk 1 Width (in)	N/A	N/A	X Walk 2 Width (in)	N/A
	X Walk 1 Slope (%)	4.2		X Walk 2 Slope (%)	0.9
	X Walk 1 X Slope (%)	2.1		X Walk 2 X Slope (%)	4.3

N/A	Ramp inside XWalk1?	N/A	N/A	Ramp inside XWalk2?	N/A
	Road Slope (%)	2.6	N/A	Clear Space?	N/A
	Road X Slope (%)	5.7	N/A	Clear Space to XWalk (in)	N/A
N/A	Any Obstructions?	N/A	N/A	Storm Grate/Utility Hazard?	N/A
	Obstruction Type			Storm Grate/Utility Type	
		N/A			N/A
			Yes	Surface Condition? (G/P)	Good

Remove & Replace Curb Ramp With Two New Directional Ramps or Equivalent.
