# Access Compliance Report

## Public Rights-of-Way

### (Curb Ramps)

Intersection ID: 21073	Main Street: COLONY_RD	Cross Street: SHARON_VIEW_RD	Location: SE
ADA ID: 7124FED4A192	Ramp Type: PerpDiag	Initial Pass/Fail: Fail	Overall Compliance: No
		Severity Score: 22.5

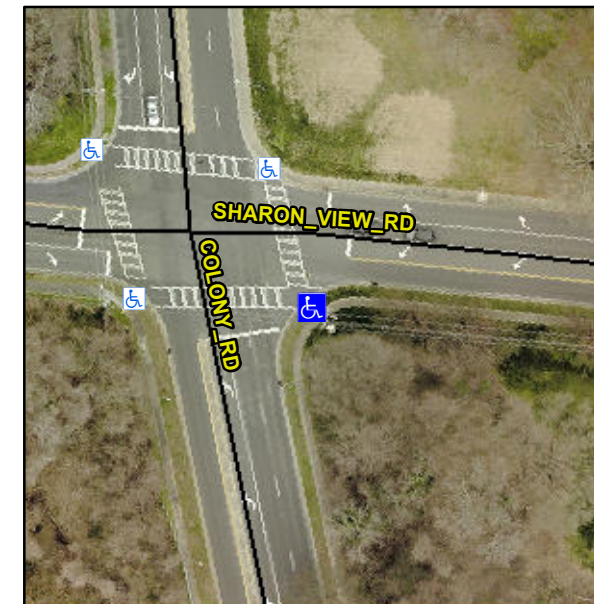
Compliance	Description	Data	Compliance	Description	Data
N/A	Ramp Length (in)	71.0	No	Ramp Slope (%)	10.5
No	Ramp Width (in)	38.0	No	Ramp XSlope (%)	4.3
N/A	Flare Type LT	N/A	N/A	Flare Type RT	N/A
N/A	Flare Slope LT (%)	N/A	N/A	Flare Slope RT (%)	N/A
N/A	Flare Traversable LT?	N/A	N/A	Flare Traversable RT?	N/A
N/A	Landing Length (in)	N/A	N/A	DWS Provided?	N/A
N/A	Landing Width (in)	N/A	N/A	DWS Contrast?	N/A
N/A	Landing Slope (%)	N/A	N/A	DWS Length (in)	N/A
N/A	Landing X Slope (%)	N/A	N/A	DWS Full Width?	N/A
N/A	Landing Curb? (Y/N)	N/A	N/A	DWS Offset (in)	N/A
N/A	Shared Landing?	N/A			
N/A	Gutter Ponding?	N/A	N/A	Gutter Slope (%)	N/A
N/A	Gutter Lip Ht (in)	N/A	N/A	Gutter X Slope (%)	N/A
N/A	Painted X Walk1?	Yes	N/A	Painted X Walk2?	Yes
	X Walk 1 Direction	To N		X Walk 2 Direction	To W
N/A	X Walk 1 Width (in)	106.0	N/A	X Walk 2 Width (in)	117.0
	X Walk 1 Slope (%)	1.5		X Walk 2 Slope (%)	4.5
	X Walk 1 X Slope (%)	3.2		X Walk 2 X Slope (%)	0.9

N/A	Ramp inside XWalk1?	Yes	N/A	Ramp inside XWalk2?	Yes
	Road Slope (%)	3.4	N/A	Clear Space?	N/A
	Road X Slope (%)	1.7	N/A	Clear Space to XWalk (in)	N/A
N/A	Any Obstructions?	N/A	N/A	Storm Grate/Utility Hazard?	N/A
	Obstruction Type			Storm Grate/Utility Type	
		N/A			N/A
		Yes		Surface Condition? (G/P)	Good

**Remove & Replace Curb Ramp With Two New Directional Ramps or Equivalent.**

**R304.5.1, R304.2.2, R304.5.3**
