Access Compliance Report

Public Rights-of-Way

(Curb Ramps)

Intersection ID: 9521	Main Street: LAKEVIEW_ST	Cross Street: NORWOOD_DR	Location: S
ADA ID: 71295B29D3E7	Ramp Type: BlendTrans1	Initial Pass/Fail: Fail	Overall Compliance: No
Severity Score: 8.75			
Codes/Mitigation Info/Possible Solution		Field Measurements/Component Compliance

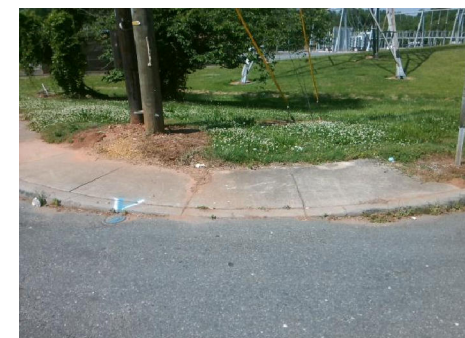
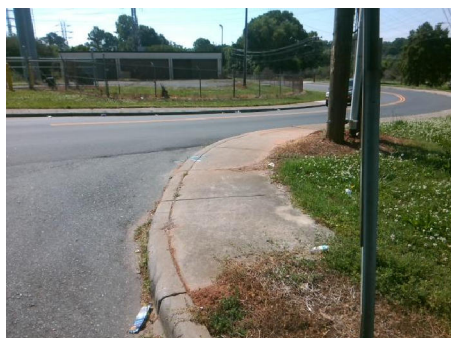
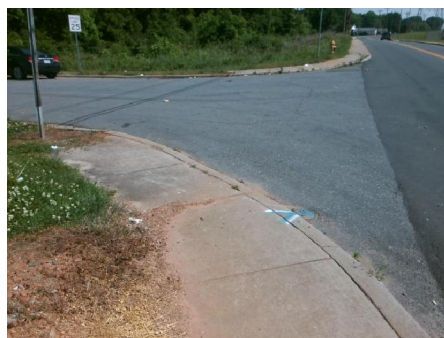
NO RT SW

Not Found, R304.5.1

Compliance	Description	Data	Compliance	Description	Data
N/A	Ramp Length (in)	54.0	Yes	BlendTrans Slope (%)	2.7
No	Ramp Width (in)	42.5	Yes	BlendTrans XSlope (%)	0.4
N/A	Flare Type LT	N/A	N/A	Flare Type RT	N/A
N/A	Flare Slope LT (%)	N/A	N/A	Flare Slope RT (%)	N/A
N/A	Flare Traversable LT?	N/A	N/A	Flare Traversable RT?	N/A
N/A	Landing Length (in)	N/A	N/A	DWS Provided?	N/A
N/A	Landing Width (in)	N/A	N/A	DWS Contrast?	N/A
N/A	Landing Slope (%)	N/A	N/A	DWS Length (in)	N/A
N/A	Landing X Slope (%)	N/A	N/A	DWS Full Width?	N/A
N/A	Landing Curb? (Y/N)	N/A	N/A	DWS Offset (in)	N/A
N/A	Shared Landing?	N/A			
N/A	Gutter Ponding?	N/A	N/A	Gutter Slope (%)	N/A
N/A	Gutter Lip Ht (in)	N/A	N/A	Gutter X Slope (%)	N/A
N/A	Painted X Walk1?	No	N/A	Painted X Walk2?	N/A
	X Walk 1 Direction	To N		X Walk 2 Direction	N/A
	X Walk 1 Width (in)	N/A		X Walk 2 Width (in)	N/A
	X Walk 1 Slope (%)	5.0		X Walk 2 Slope (%)	N/A
	X Walk 1 X Slope (%)	1.4		X Walk 2 X Slope (%)	N/A

N/A	Ramp inside XWalk1?	N/A	N/A	Ramp inside XWalk2?	N/A
	Road Slope (%)	1.4		Clear Space?	N/A
	Road X Slope (%)	5.0	N/A	Clear Space to XWalk (in)	N/A
N/A	Any Obstructions?	N/A	N/A	Storm Grate/Utility Hazard?	N/A
	Obstruction Type			Storm Grate/Utility Type	
		N/A			N/A
			Yes	Surface Condition? (G/P)	Good
			No	Curb Slope (%)	6.8

Possible Solutions:

Remove & Replace Curb Ramp With Two New Directional Ramps or Equivalent.
