Access Compliance Report

Public Rights-of-Way

(Curb Ramps)

Intersection ID: 47457	Main Street: STEELE_CREEK_RD	Cross Street: WINGED_TEAL_RD	Location: NE
ADA ID: 712A7D0201C3	Ramp Type: Perp	Initial Pass/Fail: Fail	Overall Compliance: No
Severity Score: 10			
Codes/Mitigation Info/Possible Solution		Field Measurements/Component Compliance

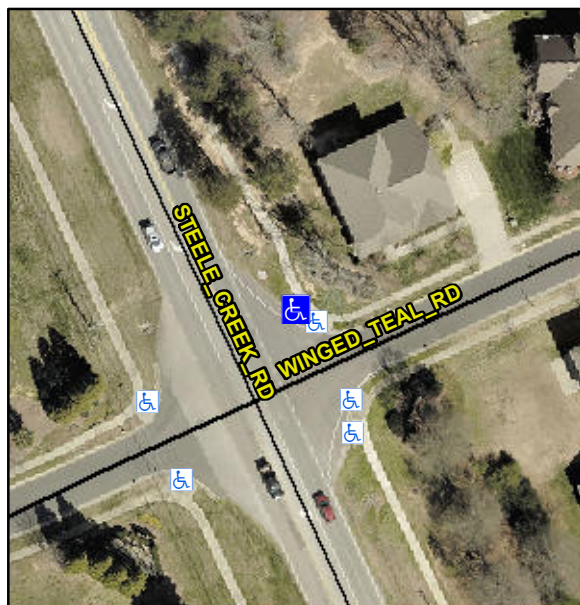
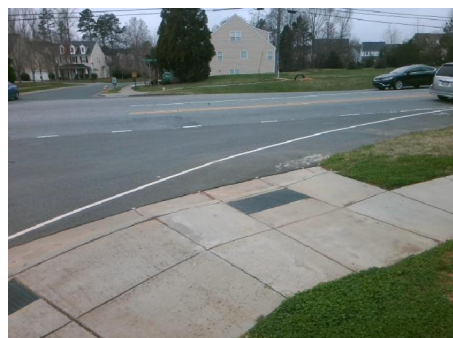
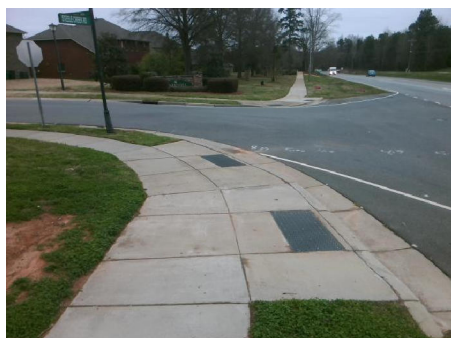
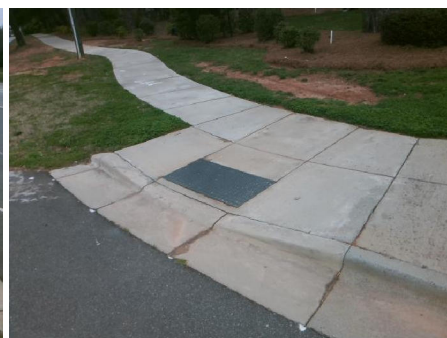
Not Found, R304.5.1

Compliance	Description	Data	Compliance	Description	Data
N/A	Ramp Length (in)	48.0	Yes	Ramp Slope (%)	5.4
No	Ramp Width (in)	46.5	Yes	Ramp XSlope (%)	2.1
N/A	Flare Type LT	N/A	N/A	Flare Type RT	N/A
N/A	Flare Slope LT (%)	N/A	N/A	Flare Slope RT (%)	N/A
N/A	Flare Traversable LT?	N/A	N/A	Flare Traversable RT?	N/A
N/A	Landing Length (in)	N/A	N/A	DWS Provided?	N/A
N/A	Landing Width (in)	N/A	N/A	DWS Contrast?	N/A
N/A	Landing Slope (%)	N/A	N/A	DWS Length (in)	N/A
N/A	Landing X Slope (%)	N/A	N/A	DWS Full Width?	N/A
N/A	Landing Curb? (Y/N)	N/A	N/A	DWS Offset (in)	N/A
N/A	Shared Landing?	N/A			
N/A	Gutter Ponding?	N/A	N/A	Gutter Slope (%)	N/A
N/A	Gutter Lip Ht (in)	N/A	N/A	Gutter X Slope (%)	N/A
N/A	Painted X Walk1?	No	N/A	Painted X Walk2?	N/A
	X Walk 1 Direction	To SW		X Walk 2 Direction	N/A
N/A	X Walk 1 Width (in)	N/A	N/A	X Walk 2 Width (in)	N/A
	X Walk 1 Slope (%)	0.5		X Walk 2 Slope (%)	N/A
	X Walk 1 X Slope (%)	4.4		X Walk 2 X Slope (%)	N/A

N/A	Ramp inside XWalk1?	N/A	N/A	Ramp inside XWalk2?	N/A
	Road Slope (%)	N/A	N/A	Clear Space?	N/A
	Road X Slope (%)	N/A	N/A	Clear Space to XWalk (in)	N/A
N/A	Any Obstructions?	N/A	N/A	Storm Grate/Utility Hazard?	N/A
	Obstruction Type			Storm Grate/Utility Type	
		N/A			N/A
			Yes	Surface Condition? (G/P)	Good

Remove & Replace Entire Ramp.

Total Cost: \$ 1850.00
