Access Compliance Report

Public Rights-of-Way

(Curb Ramps)

Intersection ID: 50341	Main Street: SCONE_PALACE_CT	Cross Street: CASTLECOVE_RD	Location: SE
ADA ID: 712C6E52D11B	Ramp Type: PerpDiag	Initial Pass/Fail: Fail	Overall Compliance: No
Codes/Mitigation Info/Possible Solution		Field Measurements/Component Compliance	
Severity Score: 21.25

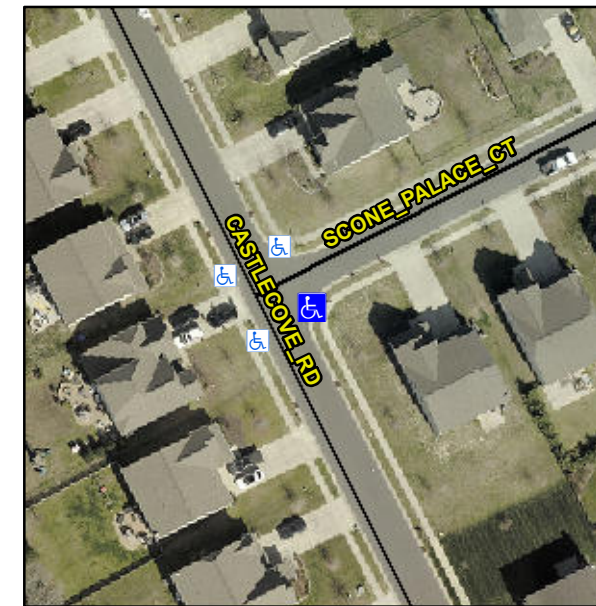
Compliance	Description	Data	Compliance	Description	Data
N/A	Ramp Length (in)	47.0	No	Ramp Slope (%)	9.1
No	Ramp Width (in)	47.0	Yes	Ramp XSlope (%)	1.6
N/A	Flare Type LT	N/A	N/A	Flare Type RT	N/A
N/A	Flare Slope LT (%)	N/A	N/A	Flare Slope RT (%)	N/A
N/A	Flare Traversable LT?	N/A	N/A	Flare Traversable RT?	N/A
N/A	Landing Length (in)	N/A	N/A	DWS Provided?	N/A
N/A	Landing Width (in)	N/A	N/A	DWS Contrast?	N/A
N/A	Landing Slope (%)	N/A	N/A	DWS Length (in)	N/A
N/A	Landing X Slope (%)	N/A	N/A	DWS Full Width?	N/A
N/A	Landing Curb? (Y/N)	N/A	N/A	DWS Offset (in)	N/A
N/A	Shared Landing?	N/A			
N/A	Gutter Ponding?	N/A	N/A	Gutter Slope (%)	N/A
N/A	Gutter Lip Ht (in)	N/A	N/A	Gutter X Slope (%)	N/A
N/A	Painted X Walk1?	No	N/A	Painted X Walk2?	No
	X Walk 1 Direction	To NW		X Walk 2 Direction	To SW
N/A	X Walk 1 Width (in)	N/A	N/A	X Walk 2 Width (in)	N/A
	X Walk 1 Slope (%)	1.4		X Walk 2 Slope (%)	4.3
	X Walk 1 X Slope (%)	0.8		X Walk 2 X Slope (%)	2.4

N/A	Ramp inside XWalk1?	N/A	N/A	Ramp inside XWalk2?	N/A
	Road Slope (%)	1.2	N/A	Clear Space?	N/A
	Road X Slope (%)	1.8	N/A	Clear Space to XWalk (in)	N/A
N/A	Any Obstructions?	N/A	N/A	Storm Grate/Utility Hazard?	N/A
	Obstruction Type			Storm Grate/Utility Type	
		N/A			N/A
			Yes	Surface Condition? (G/P)	Good

Remove & Replace Curb Ramp With Two New Directional Ramps or Equivalent.
