Access Compliance Report Public Rights-of-Way (Curb Ramps)

Intersection ID: 15053Main Street: COLVILLE_RDCross Street: FENTON_PLLocation: NWADA ID: 712CDF046133Ramp Type: ParaDiagInitial Pass/Fail: FailOverall Compliance: NoSeverity Score: 25

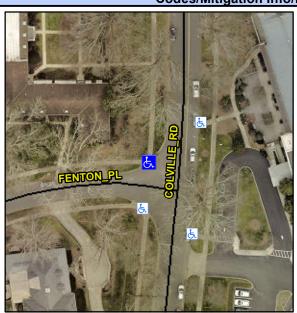
Field Measurements/Component Compliance					
Compliance Description		Data	Comp	liance Description	Data
N/A	Ramp Length LT (in)	52.0	N/A	Ramp Length RT (in)	N/A
Yes	Ramp Width LT (in)	63.5	N/A	Ramp Width RT (in)	N/A
No	Ramp Slope LT (%)	8.4	N/A	Ramp Slope RT (%)	N/A
No	Ramp XSlope LT (%)	5.1	N/A	Ramp XSlope RT (%)	N/A
N/A	Landing Length (in)	N/A	N/A	DWS Provided?	N/A
N/A	Landing Width (in)	N/A	N/A	DWS Contrast?	N/A
N/A	Landing Slope (%)	N/A	N/A	DWS Length (in)	N/A
N/A	Landing X Slope (%)	N/A	N/A	DWS Full Width?	N/A
N/A	Landing Curb? (Y/N)	N/A	N/A	DWS Offset (in)	N/A
N/A	Shared Landing?	N/A			
N/A	Gutter Ponding?	N/A	N/A	Gutter Slope (%)	N/A
N/A	Gutter Lip Ht (in)	N/A	N/A	Gutter X Slope (%)	N/A
N/A	Painted X Walk1?	No	N/A	Painted X Walk2?	No
	X Walk 1 Direction	To S		X Walk 2 Direction	To E
N/A	X Walk 1 Width (in)	N/A	N/A	X Walk 2 Width (in)	N/A
	X Walk 1 Slope (%)	0.1		X Walk 2 Slope (%)	0.3
	X Walk 1 X Slope (%)	3.0		X Walk 2 X Slope (%)	1.9

N/A	Ramp inside XWalk1?	N/A	N/A	Ramp inside XWalk2?	N/A
	Road Slope (%)	3.3	N/A	Clear Space?	N/A
	Road X Slope (%)	2.2	N/A	Clear Space to XWalk (in)	N/A
N/A	Any Obstructions?	N/A	N/A	Storm Grate/Utility Hazard?	N/A
	Obstruction Type			Storm Grate/Utility Type	
		N/A			N/A
			Yes	Surface Condition? (G/P)	Good
			N/A	Curb Slope (%)	11.1
111	R. B. Aller				
11

Remove & Replace Curb Ramp With
Two New Directional Ramps or
Equivalent.

PROW/ADA:
R304.3.2, R304.5.3
