Access Compliance Report

Public Rights-of-Way

(Curb Ramps)

Intersection ID: 23917	Main Street: BOSHAM_LN	Cross Street: WHITWORTH_WY	Location: SW
ADA ID: 7139CB214BDF	Ramp Type: Perp	Initial Pass/Fail: Fail	Overall Compliance: No
Severity Score: 12.5			
Codes/Mitigation Info/Possible Solution		Field Measurements/Component Compliance

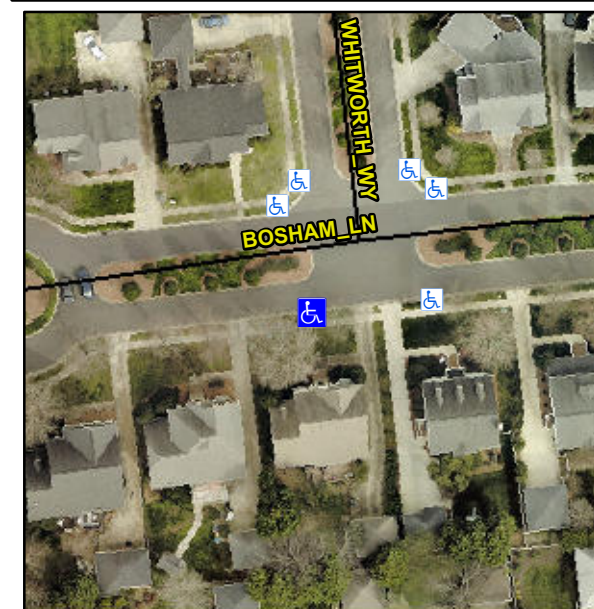
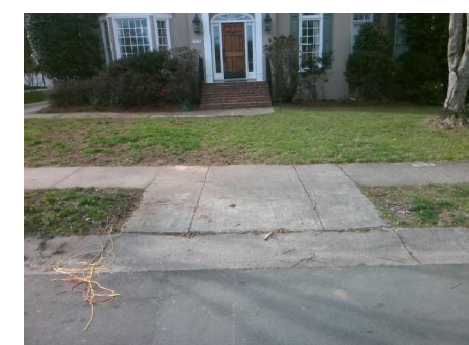
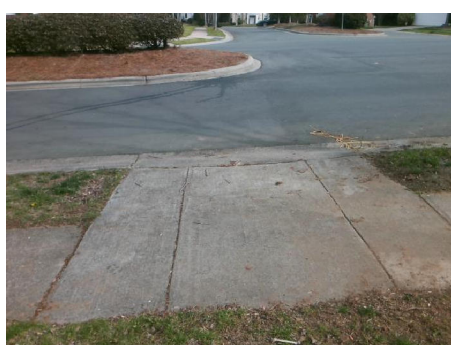
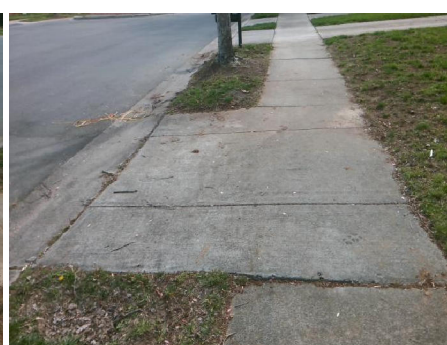
Not Found, R304.5.3

Compliance	Description	Data	Compliance	Description	Data
N/A	Ramp Length (in)	50.0	Yes	Ramp Slope (%)	6.1
Yes	Ramp Width (in)	54.0	No	Ramp XSlope (%)	5.2
N/A	Flare Type LT	N/A	N/A	Flare Type RT	N/A
N/A	Flare Slope LT (%)	N/A	N/A	Flare Slope RT (%)	N/A
N/A	Flare Traversable LT?	N/A	N/A	Flare Traversable RT?	N/A
N/A	Landing Length (in)	N/A	N/A	DWS Provided?	N/A
N/A	Landing Width (in)	N/A	N/A	DWS Contrast?	N/A
N/A	Landing Slope (%)	N/A	N/A	DWS Length (in)	N/A
N/A	Landing X Slope (%)	N/A	N/A	DWS Full Width?	N/A
N/A	Landing Curb? (Y/N)	N/A	N/A	DWS Offset (in)	N/A
N/A	Shared Landing?	N/A			
N/A	Gutter Ponding?	N/A	N/A	Gutter Slope (%)	N/A
N/A	Gutter Lip Ht (in)	N/A	N/A	Gutter X Slope (%)	N/A
N/A	Painted X Walk1?	No	N/A	Painted X Walk2?	N/A
	X Walk 1 Direction	To N		X Walk 2 Direction	N/A
N/A	X Walk 1 Width (in)	N/A	N/A	X Walk 2 Width (in)	N/A
	X Walk 1 Slope (%)	2.9		X Walk 2 Slope (%)	N/A
	X Walk 1 X Slope (%)	3.4		X Walk 2 X Slope (%)	N/A

N/A	Ramp inside XWalk1?	N/A	N/A	Ramp inside XWalk2?	N/A
	Road Slope (%)	N/A	N/A	Clear Space?	N/A
	Road X Slope (%)	N/A	N/A	Clear Space to XWalk (in)	N/A
N/A	Any Obstructions?	N/A	N/A	Storm Grate/Utility Hazard?	N/A
	Obstruction Type			Storm Grate/Utility Type	
		N/A			N/A
			Yes	Surface Condition? (G/P)	Good

Possible Solutions:

Remove & Replace Entire Ramp.
