Access Compliance Report

Public Rights-of-Way

(Curb Ramps)

Intersection ID: 30117	Main Street: CLOONEY_LN	Cross Street: DAVIS_FOREST_LN	Location: NW
ADA ID: 71407E5A4984	Ramp Type: PerpDiag	Initial Pass/Fail: Fail	Overall Compliance: No
Severity Score: 12.5			
Codes/Mitigation Info/Possible Solution		Field Measurements/Component Compliance

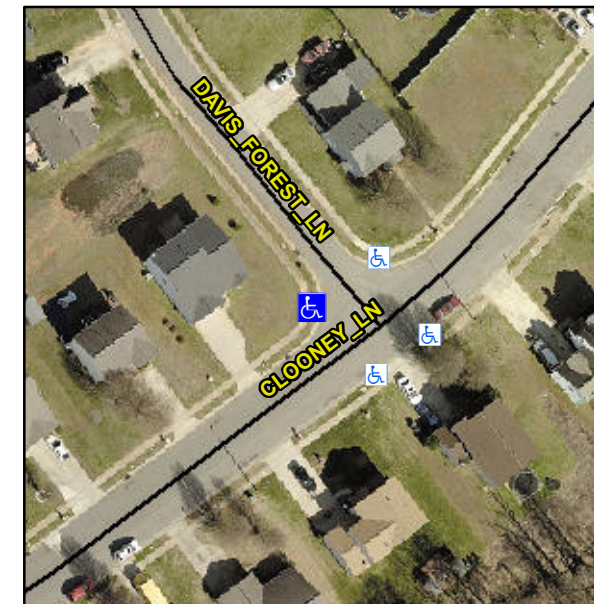
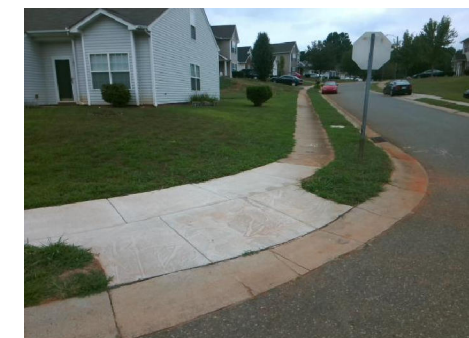
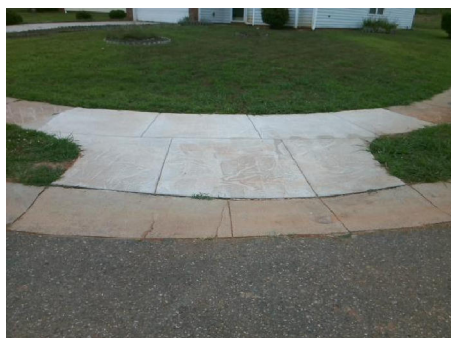
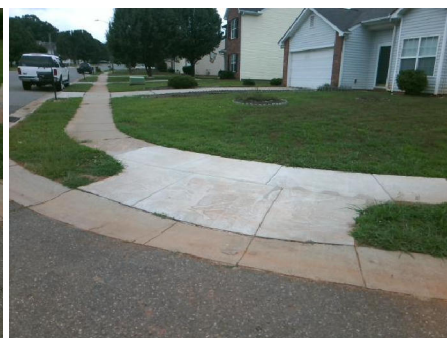
Compliance	Description	Data	Compliance	Description	Data
N/A	Ramp Length (in)	54.0	No	Ramp Slope (%)	10.6
Yes	Ramp Width (in)	54.0	Yes	Ramp XSlope (%)	1.5
N/A	Flare Type LT	N/A	N/A	Flare Type RT	N/A
N/A	Flare Slope LT (%)	N/A	N/A	Flare Slope RT (%)	N/A
N/A	Flare Traversable LT?	N/A	N/A	Flare Traversable RT?	N/A
N/A	Landing Length (in)	N/A	N/A	DWS Provided?	N/A
N/A	Landing Width (in)	N/A	N/A	DWS Contrast?	N/A
N/A	Landing Slope (%)	N/A	N/A	DWS Length (in)	N/A
N/A	Landing X Slope (%)	N/A	N/A	DWS Full Width?	N/A
N/A	Landing Curb? (Y/N)	N/A	N/A	DWS Offset (in)	N/A
N/A	Shared Landing?	N/A			
N/A	Gutter Ponding?	N/A	N/A	Gutter Slope (%)	N/A
N/A	Gutter Lip Ht (in)	N/A	N/A	Gutter X Slope (%)	N/A
N/A	Painted X Walk1?	No	N/A	Painted X Walk2?	No
	X Walk 1 Direction	To SE		X Walk 2 Direction	To NE
N/A	X Walk 1 Width (in)	N/A	N/A	X Walk 2 Width (in)	N/A
	X Walk 1 Slope (%)	1.0		X Walk 2 Slope (%)	2.0
	X Walk 1 X Slope (%)	2.6		X Walk 2 X Slope (%)	0.6

N/A	Ramp inside XWalk1?	N/A	N/A	Ramp inside XWalk2?	N/A
	Road Slope (%)	0.8	N/A	Clear Space?	N/A
	Road X Slope (%)	2.1	N/A	Clear Space to XWalk (in)	N/A
N/A	Any Obstructions?	N/A	N/A	Storm Grate/Utility Hazard?	N/A
	Obstruction Type			Storm Grate/Utility Type	
		N/A			N/A
			Yes	Surface Condition? (G/P)	Good

Remove & Replace Curb Ramp With Two New Directional Ramps or Equivalent.
