Access Compliance Report

Public Rights-of-Way

(Curb Ramps)

Intersection ID: 28386	Main Street: MARVIN_RD	Cross Street: SOUTHAMPTON_COMMONS_DR	Location: N
ADA ID: 71427859E166	Ramp Type: Perp	Initial Pass/Fail: Fail	Overall Compliance: No
Severity Score: 22.5			
Codes/Mitigation Info/Possible Solution		Field Measurements/Component Compliance

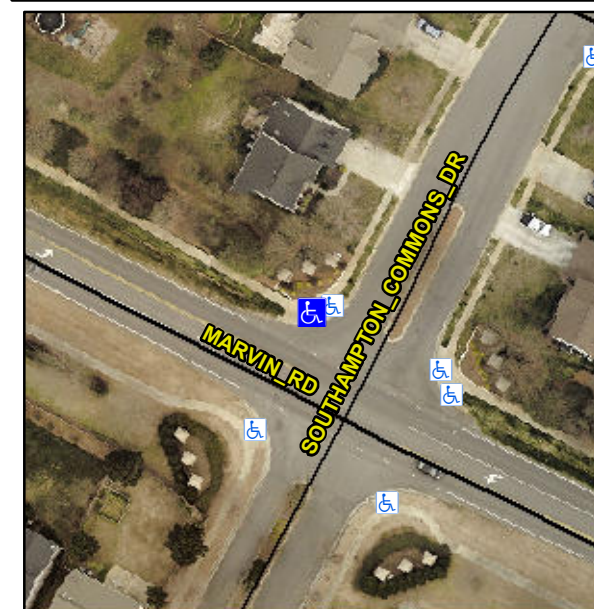
Not Found, R304.5.1, R304.2.2, R304.5.3

Compliance	Description	Data	Compliance	Description	Data
N/A	Ramp Length (in)	53.0	No	Ramp Slope (%)	9.9
No	Ramp Width (in)	36.0	No	Ramp XSlope (%)	3.0
N/A	Flare Type LT	N/A	N/A	Flare Type RT	N/A
N/A	Flare Slope LT (%)	N/A	N/A	Flare Slope RT (%)	N/A
N/A	Flare Traversable LT?	N/A	N/A	Flare Traversable RT?	N/A
N/A	Landing Length (in)	N/A	N/A	DWS Provided?	N/A
N/A	Landing Width (in)	N/A	N/A	DWS Contrast?	N/A
N/A	Landing Slope (%)	N/A	N/A	DWS Length (in)	N/A
N/A	Landing X Slope (%)	N/A	N/A	DWS Full Width?	N/A
N/A	Landing Curb? (Y/N)	N/A	N/A	DWS Offset (in)	N/A
N/A	Shared Landing?	N/A			
N/A	Gutter Ponding?	N/A	N/A	Gutter Slope (%)	N/A
N/A	Gutter Lip Ht (in)	N/A	N/A	Gutter X Slope (%)	N/A
N/A	Painted X Walk1?	No	N/A	Painted X Walk2?	N/A
	X Walk 1 Direction	To SW		X Walk 2 Direction	N/A
N/A	X Walk 1 Width (in)	N/A	N/A	X Walk 2 Width (in)	N/A
	X Walk 1 Slope (%)	0.4		X Walk 2 Slope (%)	N/A
	X Walk 1 X Slope (%)	0.5		X Walk 2 X Slope (%)	N/A

N/A	Ramp inside XWalk1?	N/A	N/A	Ramp inside XWalk2?	N/A
	Road Slope (%)	N/A	N/A	Clear Space?	N/A
	Road X Slope (%)	N/A	N/A	Clear Space to XWalk (in)	N/A
N/A	Any Obstructions?	N/A	N/A	Storm Grate/Utility Hazard?	N/A
	Obstruction Type			Storm Grate/Utility Type	
		N/A			N/A
			Yes	Surface Condition? (G/P)	Good

Possible Solutions:

Remove & Replace Entire Ramp.
