## Access Compliance Report Public Rights-of-Way (Curb Ramps)

Intersection ID: 10023974Main Street: COPPER\_LEAF\_LNCross Street: N/ALocation:NEADA ID: 7142807F9CAFRamp Type: PerpInitial Pass/Fail: PassOverall Compliance: NoSeverity Score: 22.5

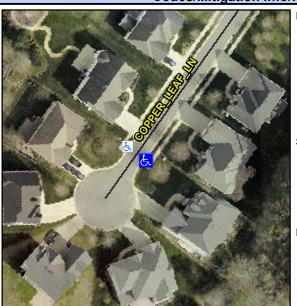
Yes	Ramp Width (in)	49.0	Yes	Ramp XSlope (%)
N/A	Flare Type LT	Sloped	N/A	Flare Type RT
N/A	Flare Slope LT (%)	4.7	N/A	Flare Slope RT (%)
N/A	Flare Traversable LT?	Yes	N/A	Flare Traversable RT?
Yes	Landing Length (in)	48.0	No	DWS Provided?
Yes	Landing Width (in)	49.0	N/A	DWS Contrast?
Yes	Landing Slope (%)	1.6	N/A	DWS Length (in)
Yes	Landing X Slope (%)	1.5	N/A	DWS Full Width?
N/A	Landing Curb? (Y/N)	No	N/A	DWS Offset (in)
N/A	Shared Landing?	No		
Yes	Gutter Ponding?	No	No	Gutter Slope (%)
No	Gutter Lip Ht (in)	0.5	Yes	Gutter X Slope (%)
N/A	Painted X Walk1?	No	N/A	Painted X Walk2?
	X Walk 1 Direction	To NW		X Walk 2 Direction
N/A	X Walk 1 Width (in)	N/A	N/A	X Walk 2 Width (in)
	X Walk 1 Slope (%)	0.7		X Walk 2 Slope (%)
	X Walk 1 X Slope (%)	1.5		X Walk 2 X Slope (%)
N/A	Ramp inside XWalk1?	N/A	N/A	Ramp inside XWalk2?
	Road Slope (%)	N/A	N/A	Clear Space?
	Road X Slope (%)	N/A	N/A	Clear Space to XWalk (in)
Yes	Any Obstructions?	No	Yes	Storm Grate/Utility Hazard?

Possible Solutions:

Remove & Replace Entire Ramp.
Remove & Replace Gutter.

PROW/ADA:
Not Found, R305, R302.7.2, R304.5.4
