Access Compliance Report

Public Rights-of-Way

(Curb Ramps)

Intersection ID: 47114	Main Street: DIXON_BRANCH_LN	Cross Street: TINDLE_HILL_LN	Location: SW
ADA ID: 71453849BF54	Ramp Type: PerpDiag	Initial Pass/Fail: Fail	Overall Compliance: No
		Severity Score: 10

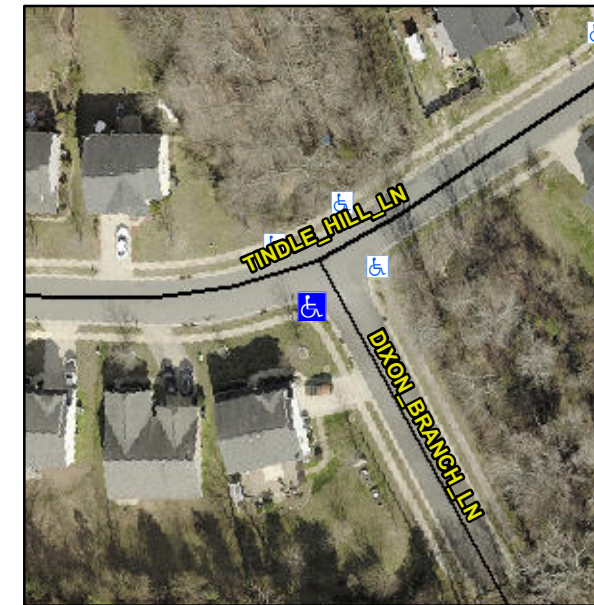
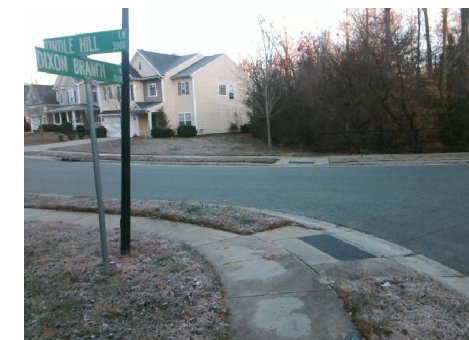
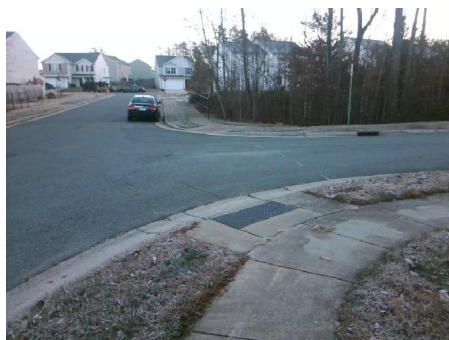
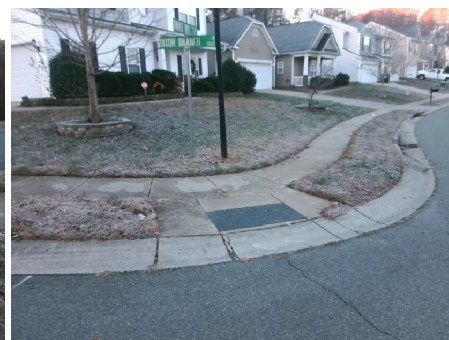
Not Found, R304.5.1, R304.5.3

Compliance	Description	Data	Compliance	Description	Data
N/A	Ramp Length (in)	46.0	Yes	Ramp Slope (%)	6.8
No	Ramp Width (in)	46.5	No	Ramp XSlope (%)	4.5
N/A	Flare Type LT	N/A	N/A	Flare Type RT	N/A
N/A	Flare Slope LT (%)	N/A	N/A	Flare Slope RT (%)	N/A
N/A	Flare Traversable LT?	N/A	N/A	Flare Traversable RT?	N/A
N/A	Landing Length (in)	N/A	N/A	DWS Provided?	N/A
N/A	Landing Width (in)	N/A	N/A	DWS Contrast?	N/A
N/A	Landing Slope (%)	N/A	N/A	DWS Length (in)	N/A
N/A	Landing X Slope (%)	N/A	N/A	DWS Full Width?	N/A
N/A	Landing Curb? (Y/N)	N/A	N/A	DWS Offset (in)	N/A
N/A	Shared Landing?	N/A			
N/A	Gutter Ponding?	N/A	N/A	Gutter Slope (%)	N/A
N/A	Gutter Lip Ht (in)	N/A	N/A	Gutter X Slope (%)	N/A
N/A	Painted X Walk1?	No	N/A	Painted X Walk2?	No
	X Walk 1 Direction	To E		X Walk 2 Direction	To N
N/A	X Walk 1 Width (in)	N/A	N/A	X Walk 2 Width (in)	N/A
	X Walk 1 Slope (%)	0.1		X Walk 2 Slope (%)	1.5
	X Walk 1 X Slope (%)	0.2		X Walk 2 X Slope (%)	2.7

N/A	Ramp inside XWalk1?	N/A	N/A	Ramp inside XWalk2?	N/A
	Road Slope (%)	2.0	N/A	Clear Space?	N/A
	Road X Slope (%)	4.3	N/A	Clear Space to XWalk (in)	N/A
N/A	Any Obstructions?	N/A	N/A	Storm Grate/Utility Hazard?	N/A
	Obstruction Type			Storm Grate/Utility Type	
		N/A			N/A
		Yes		Surface Condition? (G/P)	Good

Remove & Replace Curb Ramp With Two New Directional Ramps or Equivalent.
