Access Compliance Report

Public Rights-of-Way

(Curb Ramps)

Intersection ID: 14350	Main Street: CENTRAL_AV	Cross Street: WINTERFIELD_PL	Location: SW
ADA ID: 7148F938303D	Ramp Type: BlendTrans1	Initial Pass/Fail: Fail	Overall Compliance: No
Severity Score: 10			
Codes/Mitigation Info/Possible Solution		Field Measurements/Component Compliance

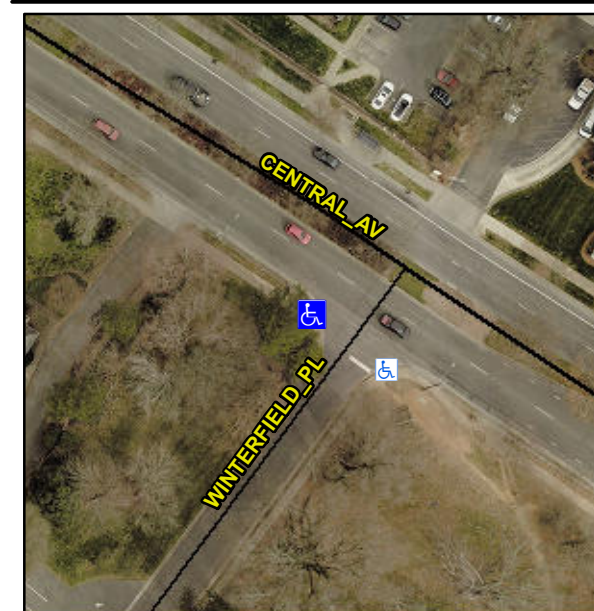
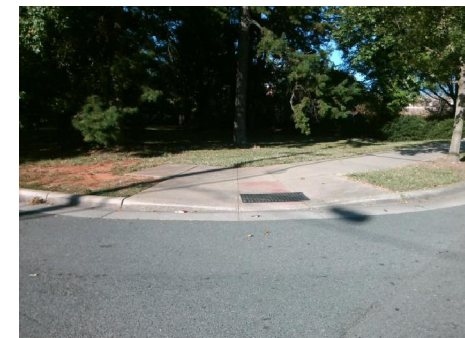
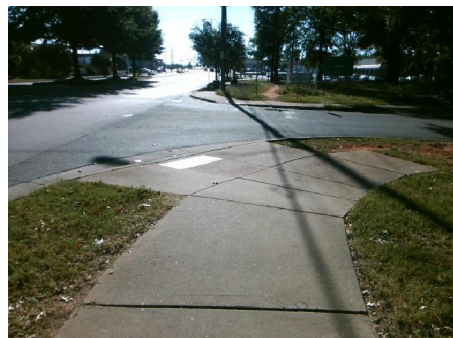
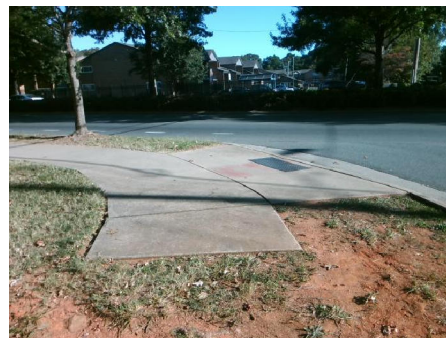
NO LT SW

Not Found, R304.5.1, R304.5.3

Compliance	Description	Data	Compliance	Description	Data
N/A	Ramp Length (in)	72.0	Yes	BlendTrans Slope (%)	3.8
No	Ramp Width (in)	36.0	No	BlendTrans XSlope (%)	2.7
N/A	Flare Type LT	N/A	N/A	Flare Type RT	N/A
N/A	Flare Slope LT (%)	N/A	N/A	Flare Slope RT (%)	N/A
N/A	Flare Traversable LT?	N/A	N/A	Flare Traversable RT?	N/A
N/A	Landing Length (in)	N/A	N/A	DWS Provided?	N/A
N/A	Landing Width (in)	N/A	N/A	DWS Contrast?	N/A
N/A	Landing Slope (%)	N/A	N/A	DWS Length (in)	N/A
N/A	Landing X Slope (%)	N/A	N/A	DWS Full Width?	N/A
N/A	Landing Curb? (Y/N)	N/A	N/A	DWS Offset (in)	N/A
N/A	Shared Landing?	N/A			
N/A	Gutter Ponding?	N/A	N/A	Gutter Slope (%)	N/A
N/A	Gutter Lip Ht (in)	N/A	N/A	Gutter X Slope (%)	N/A
N/A	Painted X Walk1?	No	N/A	Painted X Walk2?	N/A
	X Walk 1 Direction	To SE		X Walk 2 Direction	N/A
	X Walk 1 Width (in)	N/A		X Walk 2 Width (in)	N/A
	X Walk 1 Slope (%)	0.3		X Walk 2 Slope (%)	N/A
	X Walk 1 X Slope (%)	2.7		X Walk 2 X Slope (%)	N/A

N/A	Ramp inside XWalk1?	N/A	N/A	Ramp inside XWalk2?	N/A
	Road Slope (%)	2.7		Clear Space?	N/A
	Road X Slope (%)	0.3	N/A	Clear Space to XWalk (in)	N/A
N/A	Any Obstructions?	N/A	N/A	Storm Grate/Utility Hazard?	N/A
	Obstruction Type			Storm Grate/Utility Type	
		N/A			N/A
			Yes	Surface Condition? (G/P)	Good
			No	Curb Slope (%)	28.2

Possible Solutions:

Remove & Replace Curb Ramp With Two New Directional Ramps or Equivalent.

Total Cost: \$ 3200.00
