# Access Compliance Report Public Rights-of-Way (Curb Ramps)

Intersection ID: 51970	Main Street: CAMPBELL COMMONS WY	Cross Street: BALLANTYNE COMMONS PY	Location:	N
ADA ID: 71493BB4E33D	Ramp Type: Directional1	Initial Pass/Fail: Fail	Overall Compliance: No	Severity Score: 12.5

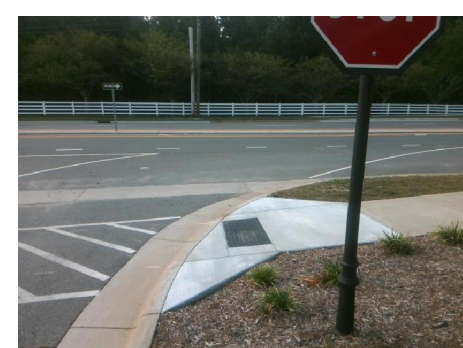
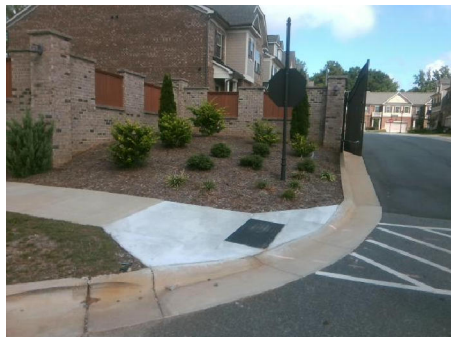
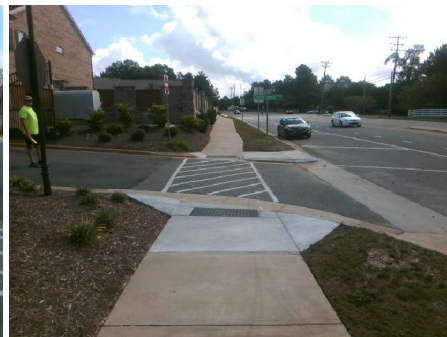
Compliance	Description	Data	Compliance	Description	Data
N/A	Ramp Length (in)	88.0	N/A	Grade Break?	N/A
Yes	Ramp Width (in)	48.0	N/A	Grade Break Slope (%)	0.0
Yes	Ramp Slope (%)	7.9	N/A	Grade Break XSlope (%)	0.0
No	Ramp XSlope (%)	6.7			
N/A	Flare Type LT	N/A	N/A	Flare Type RT	N/A
N/A	Flare Slope LT (%)	N/A	N/A	Flare Slope RT (%)	0.0
N/A	Flare Traversable LT?	N/A	N/A	Flare Traversable RT?	N/A
N/A	Landing Length (in)	0.0	N/A	DWS Provided?	N/A
N/A	Landing Width (in)	0.0	N/A	DWS Contrast?	N/A
N/A	Landing Slope (%)	0.0	N/A	DWS Length (in)	N/A
N/A	Landing X Slope (%)	0.0	N/A	DWS Full Width?	N/A
N/A	Landing Curb? (Y/N)	N/A	N/A	DWS Offset LT (in)	N/A
N/A	Shared Landing?	N/A	N/A	DWS Offset RT (in)	N/A
N/A	Gutter Ponding?	0.0	N/A	Gutter Slope (%)	N/A
N/A	Gutter Lip Ht (in)	0.0	N/A	Gutter X Slope (%)	N/A
N/A	Painted X Walk1?	Yes		Road Slope (%)	2.8
	X Walk 1 Direction	To NE		Road X Slope (%)	2.0
	X Walk 1 Width (in)	91.5		Clear Space?	N/A

X Walk 1 Slope (%)	2.8	N/A	Clear Space to XWalk (in)	N/A
	X Walk 1 X Slope (%)	2.0	N/A	Storm Grate/Utility Hazard?	N/A
N/A	Ramp inside XWalk1?	Yes		Storm Grate/Utility Type	
N/A	Any Obstructions?	N/A			N/A
	Obstruction Type		Yes	Surface Condition? (G/P)	Good
			N/A	Curb Slope (%)	17.3

**Remove & Replace Entire Ramp.**

**R304.5.3**

\$ 1600.00
