Access Compliance Report

Public Rights-of-Way

(Curb Ramps)

Intersection ID: 12972	Main Street: HAMORTON_PL	Cross Street: THOMAS_AV	Location: NE
ADA ID: 714EC5CFE49F	Ramp Type: PerpDiag	Initial Pass/Fail: Fail	Overall Compliance: No
		Severity Score: 22.5

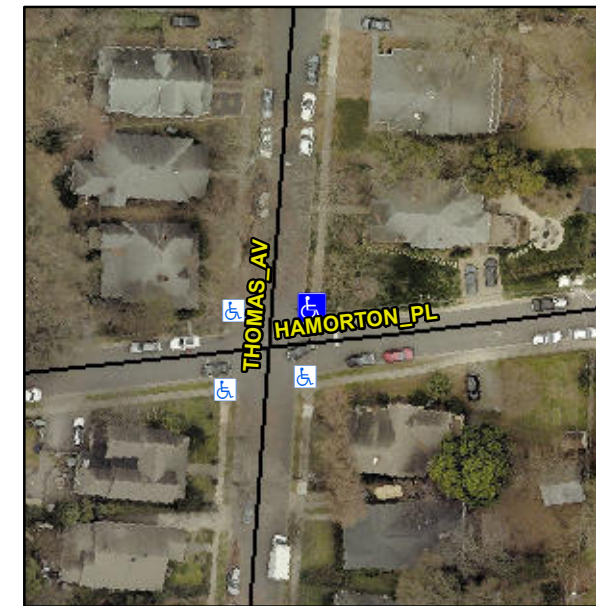
Not Found, R304.5.1, R304.2.2, R304.5.3

Compliance	Description	Data	Compliance	Description	Data
N/A	Ramp Length (in)	42.5	No	Ramp Slope (%)	11.4
No	Ramp Width (in)	39.0	No	Ramp XSlope (%)	2.3
N/A	Flare Type LT	N/A	N/A	Flare Type RT	N/A
N/A	Flare Slope LT (%)	N/A	N/A	Flare Slope RT (%)	N/A
N/A	Flare Traversable LT?	N/A	N/A	Flare Traversable RT?	N/A
N/A	Landing Length (in)	N/A	N/A	DWS Provided?	N/A
N/A	Landing Width (in)	N/A	N/A	DWS Contrast?	N/A
N/A	Landing Slope (%)	N/A	N/A	DWS Length (in)	N/A
N/A	Landing X Slope (%)	N/A	N/A	DWS Full Width?	N/A
N/A	Landing Curb? (Y/N)	N/A	N/A	DWS Offset (in)	N/A
N/A	Shared Landing?	N/A			
N/A	Gutter Ponding?	Yes	N/A	Gutter Slope (%)	N/A
N/A	Gutter Lip Ht (in)	N/A	N/A	Gutter X Slope (%)	N/A
N/A	Painted X Walk1?	No	N/A	Painted X Walk2?	No
	X Walk 1 Direction	To W		X Walk 2 Direction	To S
N/A	X Walk 1 Width (in)	N/A	N/A	X Walk 2 Width (in)	N/A
	X Walk 1 Slope (%)	2.6		X Walk 2 Slope (%)	0.6
	X Walk 1 X Slope (%)	0.8		X Walk 2 X Slope (%)	1.6

Remove & Replace Curb Ramp With Two New Directional Ramps or Equivalent.
