# Access Compliance Report

## Public Rights-of-Way

### (Curb Ramps)

| Intersection ID: 29716 | Main Street: GATESVILLE_LN | Cross Street: MEDOC_MOUNTAIN_DR | Location: N |

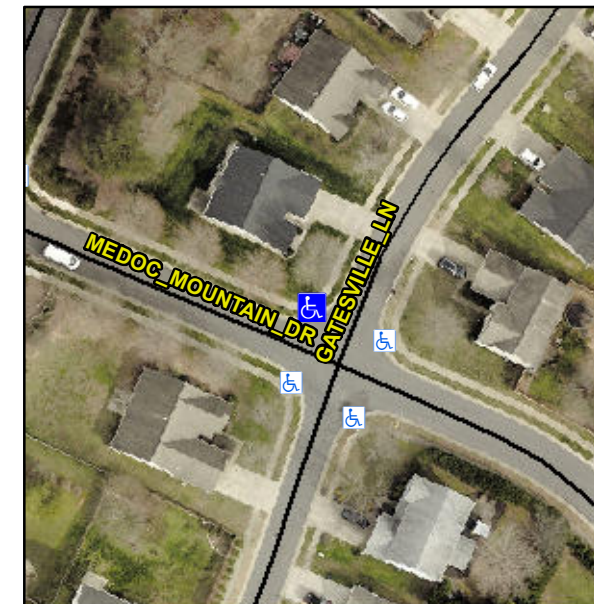
| ADA ID: 716455CCC256 | Ramp Type: PerpDiag | Initial Pass/Fail: Pass | Overall Compliance: No |
| Severity Score: 15.25 | | | |

| Compliance | Description | Data | Compliance | Description | Data |
|---|---|---|---|---|---|
| Yes | Ramp Width (in) | 54.0 | No | Ramp XSlope (%) | 4.4 |
| Yes | Landing Length (in) | 48.0 | No | DWS Provided? | No |
| No | Landing Slope (%) | 2.4 | N/A | DWS Length (in) | N/A |
| No | Landing X Slope (%) | 4.5 | N/A | DWS Full Width? | No |
| Yes | Gutter Ponding? | No | No | Gutter Slope (%) | 5.6 |
| Yes | Gutter Lip Ht (in) | 0.0 | No | Gutter X Slope (%) | 2.2 |

**Remove & Replace Curb Ramp With Two New Directional Ramps or Equivalent. Remove & Replace Gutter.**

**R304.5.3, R304.2.2-Perp, R304.3.2-Para, R305, R304.5.4**

Total Cost: \$ 3950.00
