# Access Compliance Report

## Public Rights-of-Way

### (Curb Ramps)

Intersection ID: 48365	Main Street: SULKY_PLOUGH_RD	Cross Street: RED_COW_RD	Location: NE
ADA ID: 71666290FC77	Ramp Type: PerpDiag	Initial Pass/Fail: Fail	Overall Compliance: No
Severity Score: 13.75			
Codes/Mitigation Info/Possible Solution		Field Measurements/Component Compliance

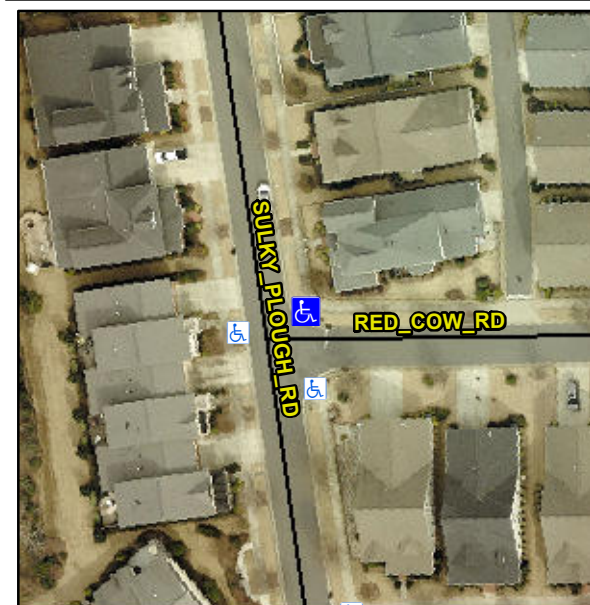
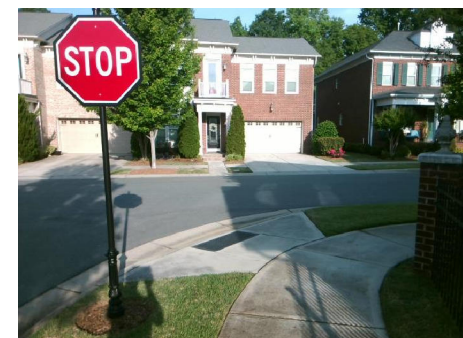
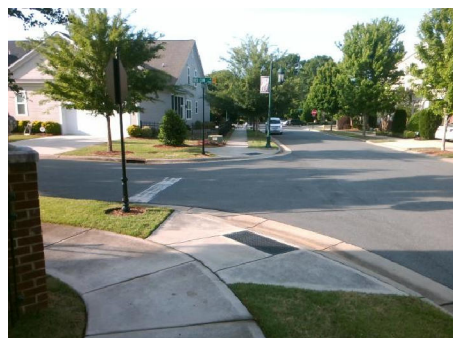
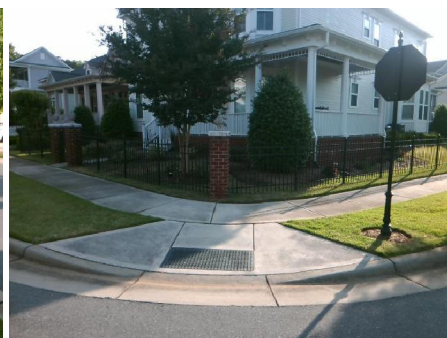
**Not Found, R304.2.2, R304.5.3**

Compliance	Description	Data	Compliance	Description	Data
N/A	Ramp Length (in)	72.0	No	Ramp Slope (%)	9.1
Yes	Ramp Width (in)	48.0	No	Ramp XSlope (%)	2.5
N/A	Flare Type LT	N/A	N/A	Flare Type RT	N/A
N/A	Flare Slope LT (%)	N/A	N/A	Flare Slope RT (%)	N/A
N/A	Flare Traversable LT?	N/A	N/A	Flare Traversable RT?	N/A
N/A	Landing Length (in)	N/A	N/A	DWS Provided?	N/A
N/A	Landing Width (in)	N/A	N/A	DWS Contrast?	N/A
N/A	Landing Slope (%)	N/A	N/A	DWS Length (in)	N/A
N/A	Landing X Slope (%)	N/A	N/A	DWS Full Width?	N/A
N/A	Landing Curb? (Y/N)	N/A	N/A	DWS Offset (in)	N/A
N/A	Shared Landing?	N/A			
N/A	Gutter Ponding?	N/A	N/A	Gutter Slope (%)	N/A
N/A	Gutter Lip Ht (in)	N/A	N/A	Gutter X Slope (%)	N/A
N/A	Painted X Walk1?	No	N/A	Painted X Walk2?	No
	X Walk 1 Direction	To W		X Walk 2 Direction	To S
N/A	X Walk 1 Width (in)	N/A	N/A	X Walk 2 Width (in)	N/A
	X Walk 1 Slope (%)	3.9		X Walk 2 Slope (%)	0.0
	X Walk 1 X Slope (%)	1.6		X Walk 2 X Slope (%)	1.1

N/A	Ramp inside XWalk1?	N/A	N/A	Ramp inside XWalk2?	N/A
	Road Slope (%)	1.0	N/A	Clear Space?	N/A
	Road X Slope (%)	1.4	N/A	Clear Space to XWalk (in)	N/A
N/A	Any Obstructions?	N/A	N/A	Storm Grate/Utility Hazard?	N/A
	Obstruction Type			Storm Grate/Utility Type	
		N/A			N/A
			Yes	Surface Condition? (G/P)	Good

**Remove & Replace Curb Ramp With Two New Directional Ramps or Equivalent.**
