Access Compliance Report

Public Rights-of-Way

(Curb Ramps)

Intersection ID: 4732	Main Street: GEMWAY_DR	Cross Street: OLDBRIAR_LN	Location:	N
ADA ID: 716CDACB4C9B	Ramp Type: Perp	Initial Pass/Fail: Fail	Overall Compliance: No	Severity Score: 13.75

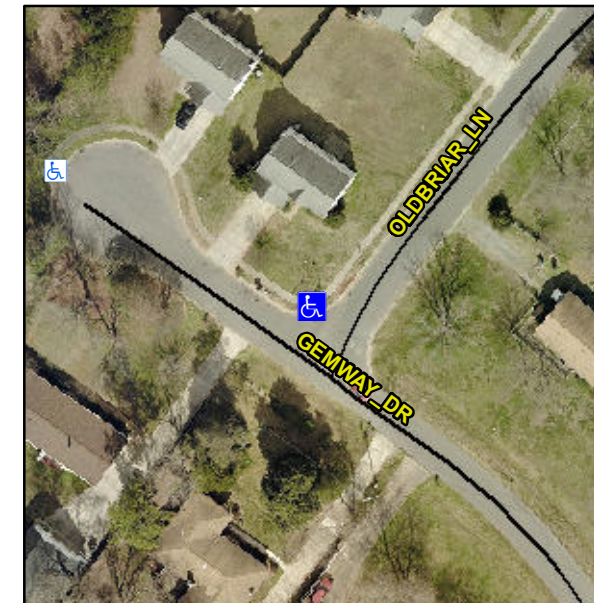
Not Found, R304.2.2, R304.5.3

Compliance	Description	Data	Compliance	Description	Data
N/A	Ramp Length (in)	48.0	No	Ramp Slope (%)	9.9
Yes	Ramp Width (in)	48.0	No	Ramp XSlope (%)	2.1
N/A	Flare Type LT	N/A	N/A	Flare Type RT	N/A
N/A	Flare Slope LT (%)	N/A	N/A	Flare Slope RT (%)	N/A
N/A	Flare Traversable LT?	N/A	N/A	Flare Traversable RT?	N/A
N/A	Landing Length (in)	N/A	N/A	DWS Provided?	N/A
N/A	Landing Width (in)	N/A	N/A	DWS Contrast?	N/A
N/A	Landing Slope (%)	N/A	N/A	DWS Length (in)	N/A
N/A	Landing X Slope (%)	N/A	N/A	DWS Full Width?	N/A
N/A	Landing Curb? (Y/N)	N/A	N/A	DWS Offset (in)	N/A
N/A	Shared Landing?	N/A			
N/A	Gutter Ponding?	N/A	N/A	Gutter Slope (%)	N/A
N/A	Gutter Lip Ht (in)	N/A	N/A	Gutter X Slope (%)	N/A
N/A	Painted X Walk1?	No	N/A	Painted X Walk2?	N/A
	X Walk 1 Direction	To SE		X Walk 2 Direction	N/A
N/A	X Walk 1 Width (in)	N/A	N/A	X Walk 2 Width (in)	N/A
	X Walk 1 Slope (%)	1.2		X Walk 2 Slope (%)	N/A
	X Walk 1 X Slope (%)	1.3		X Walk 2 X Slope (%)	N/A

N/A	Ramp inside XWalk1?	N/A	N/A	Ramp inside XWalk2?	N/A
	Road Slope (%)	1.3	N/A	Clear Space?	N/A
	Road X Slope (%)	1.2	N/A	Clear Space to XWalk (in)	N/A
N/A	Any Obstructions?	N/A	N/A	Storm Grate/Utility Hazard?	N/A
	Obstruction Type			Storm Grate/Utility Type	
		N/A			N/A
			Yes	Surface Condition? (G/P)	Good

Remove & Replace Entire Ramp.

Total Cost: \$ 1850.00
