# Access Compliance Report

## Public Rights-of-Way

### (Curb Ramps)

| Intersection ID: 45241 | Main Street: TALUS_TRACE_LN | Cross Street: TALUS_TRACE_LN | Location: NW |

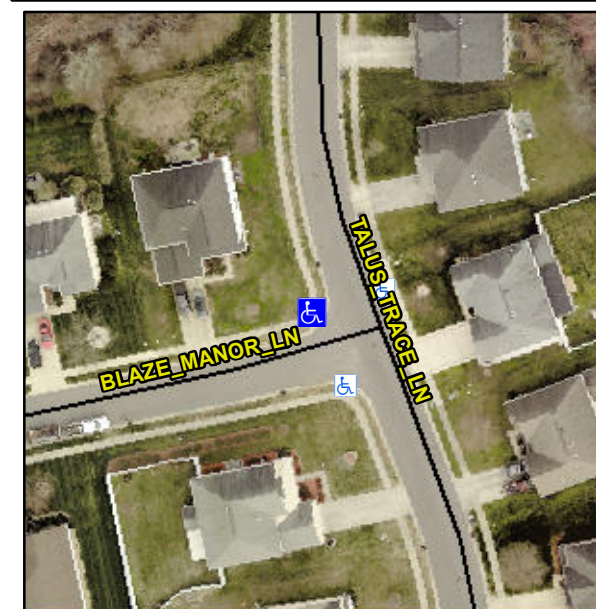
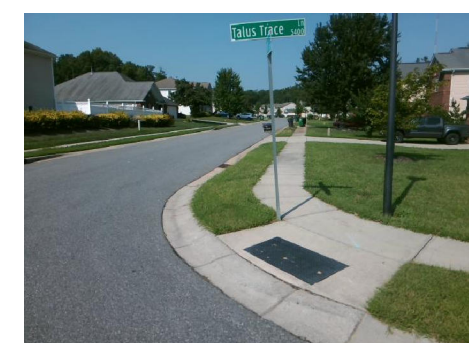
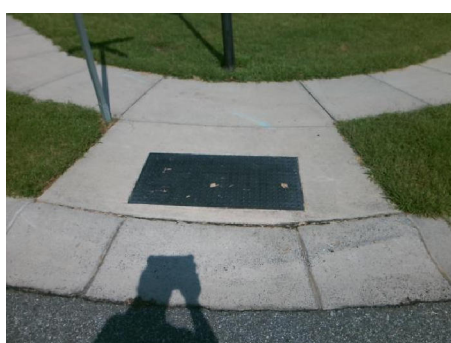
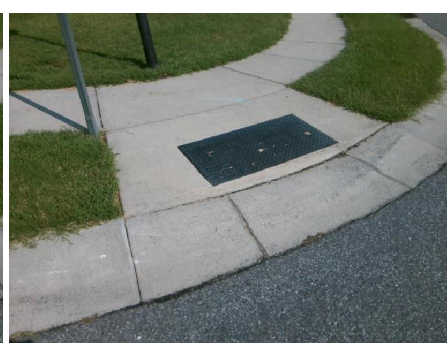
**Not Found, R304.2.1, R304.5.3, R305.2, R302.7.2**

| Compliance | Description | Data | Compliance | Description | Data |
|---|---|---|---|---|---|
| No | Landing Length (in) | 46.0 | Yes | DWS Provided? | Yes |
| No | Landing X Slope (%) | 3.0 | Yes | DWS Full Width? | Yes |
| N/A | Landing Curb? (Y/N) | No | No | DWS Offset (in) | 5.0 |
| No | Gutter Lip Ht (in) | 0.5 | No | Gutter X Slope (%) | 2.1 |

**Remove & Replace Curb Ramp With Two New Directional Ramps or Equivalent. Remove & Replace Gutter.**
