Access Compliance Report

Public Rights-of-Way

(Curb Ramps)

| Intersection ID: 14070 | Main Street: HARRISBURG_RD | Cross Street: PENCE_RD | Location: SW |

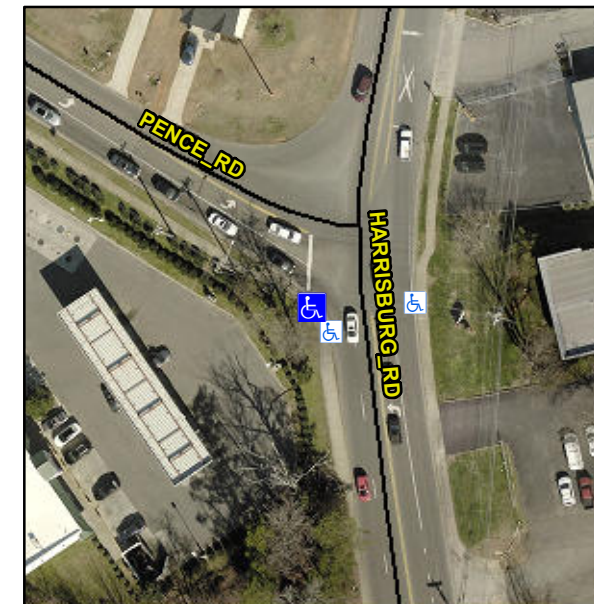
LT RP < 5%

R304.5.3, R304.3.2

| Compliance | Description | Data | Compliance | Description | Data |
|---|---|---|---|---|---|
| Yes | Ramp Slope LT (%) | 0.6 | No | Ramp Slope RT (%) | 9.3 |
| No | Ramp XSlope LT (%) | 3.9 | No | Ramp XSlope RT (%) | 2.6 |

Remove & Replace Entire Ramp.
