Access Compliance Report

Public Rights-of-Way

(Curb Ramps)

Intersection ID: 12261	Main Street: MORTON_ST	Cross Street: REMOUNT_RD	Location: NE
ADA ID: 716EDE882B13	Ramp Type: Perp	Initial Pass/Fail: Fail	Overall Compliance: No
		Severity Score: 8.75

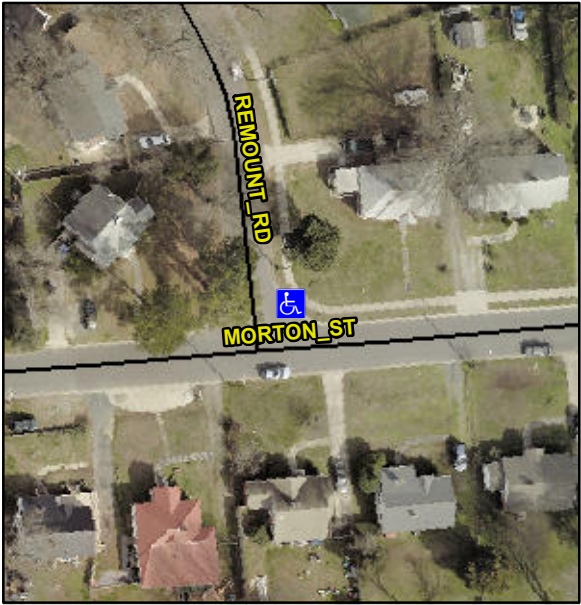
Possible Solutions:	Remove & Replace Entire Ramp.					
	Surveyor Notes:	N/A					
	PROW/ADA:	Not Found, R304.5.1					
	Street 1 Name	MORTON ST					
	Stop Condition-Street 2	None					
	Street 2 Name	N/A					
	Stop Condition-Street 1	N/A					
	Total Cost:	\$ 1850.00					
		Compliance	Description	Data	Compliance	Description	Data
		N/A	Ramp Length (in)	48.5	Yes	Ramp Slope (%)	6.7
		No	Ramp Width (in)	47.5	Yes	Ramp XSlope (%)	1.0
		N/A	Flare Type LT	N/A	N/A	Flare Type RT	N/A
		N/A	Flare Slope LT (%)	N/A	N/A	Flare Slope RT (%)	N/A
		N/A	Flare Traversable LT?	N/A	N/A	Flare Traversable RT?	N/A
		N/A	Landing Length (in)	N/A	N/A	DWS Provided?	N/A
		N/A	Landing Width (in)	N/A	N/A	DWS Contrast?	N/A
		N/A	Landing Slope (%)	N/A	N/A	DWS Length (in)	N/A
		N/A	Landing X Slope (%)	N/A	N/A	DWS Full Width?	N/A
		N/A	Landing Curb? (Y/N)	N/A	N/A	DWS Offset (in)	N/A

N/A	Shared Landing?	N/A			
		N/A	Gutter Ponding?	N/A	N/A	Gutter Slope (%)	N/A
		N/A	Gutter Lip Ht (in)	N/A	N/A	Gutter X Slope (%)	N/A
		N/A	Painted X Walk1?	No	N/A	Painted X Walk2?	N/A
			X Walk 1 Direction	To S		X Walk 2 Direction	N/A
		N/A	X Walk 1 Width (in)	N/A	N/A	X Walk 2 Width (in)	N/A
			X Walk 1 Slope (%)	5.4		X Walk 2 Slope (%)	N/A
			X Walk 1 X Slope (%)	1.6		X Walk 2 X Slope (%)	N/A
		N/A	Ramp inside XWalk1?	N/A	N/A	Ramp inside XWalk2?	N/A
			Road Slope (%)	N/A	N/A	Clear Space?	N/A
			Road X Slope (%)	N/A	N/A	Clear Space to XWalk (in)	N/A
		N/A	Any Obstructions?	N/A	N/A	Storm Grate/Utility Hazard?	N/A
			Obstruction Type			Storm Grate/Utility Type	
				N/A			N/A
					Yes	Surface Condition? (G/P)	Good
