Access Compliance Report

Public Rights-of-Way

(Curb Ramps)

Intersection ID: N/A	Main Street: HEDGEWYCK_PL	Cross Street: N/A	Location: NE
ADA ID: 7171DD8C16E5	Ramp Type: BlendTrans2	Initial Pass/Fail: Fail	Overall Compliance: No
		Severity Score: 12.5

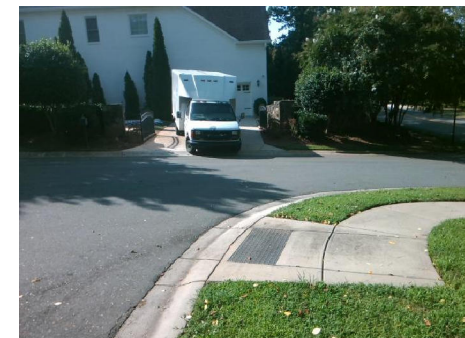
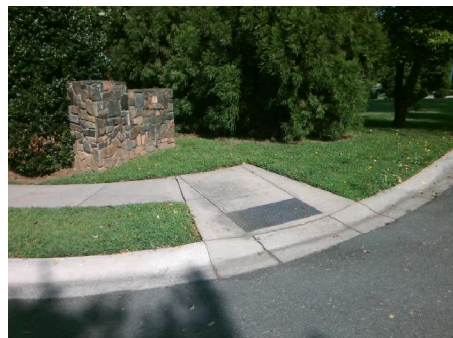
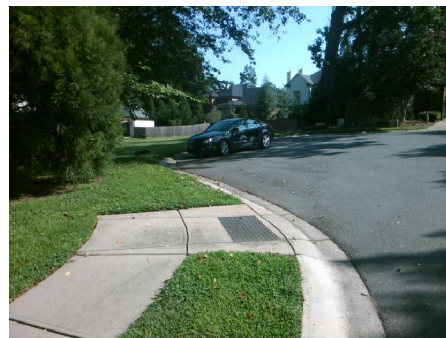
Compliance	Description	Data	Compliance	Description	Data
N/A	Ramp Length (in)	99.5	Yes	BlendTrans Slope (%)	2.2
Yes	Ramp Width (in)	48.0	No	BlendTrans XSlope (%)	6.2
N/A	Flare Type LT	N/A	N/A	Flare Type RT	N/A
N/A	Flare Slope LT (%)	N/A	N/A	Flare Slope RT (%)	N/A
N/A	Flare Traversable LT?	N/A	N/A	Flare Traversable RT?	N/A
N/A	Landing Length (in)	N/A	N/A	DWS Provided?	N/A
N/A	Landing Width (in)	N/A	N/A	DWS Contrast?	N/A
N/A	Landing Slope (%)	N/A	N/A	DWS Length (in)	N/A
N/A	Landing X Slope (%)	N/A	N/A	DWS Full Width?	N/A
N/A	Landing Curb? (Y/N)	N/A	N/A	DWS Offset (in)	N/A
N/A	Shared Landing?	N/A			
N/A	Gutter Ponding?	N/A	N/A	Gutter Slope (%)	N/A
N/A	Gutter Lip Ht (in)	N/A	N/A	Gutter X Slope (%)	N/A
N/A	Painted X Walk1?	No	N/A	Painted X Walk2?	N/A
	X Walk 1 Direction	To SE		X Walk 2 Direction	N/A
	X Walk 1 Width (in)	N/A		X Walk 2 Width (in)	N/A
	X Walk 1 Slope (%)	8.2		X Walk 2 Slope (%)	N/A
	X Walk 1 X Slope (%)	6.0		X Walk 2 X Slope (%)	N/A

N/A	Ramp inside XWalk1?	N/A	N/A	Ramp inside XWalk2?	N/A
	Road Slope (%)	6.0		Clear Space?	N/A
	Road X Slope (%)	8.2	N/A	Clear Space to XWalk (in)	N/A
N/A	Any Obstructions?	N/A	N/A	Storm Grate/Utility Hazard?	N/A
	Obstruction Type			Storm Grate/Utility Type	
		N/A			N/A
			Yes	Surface Condition? (G/P)	Good
			N/A	Curb Slope (%)	3.9

Remove & Replace Curb Ramp With Two New Directional Ramps or Equivalent.

R304.5.3
