Access Compliance Report

Public Rights-of-Way

(Curb Ramps)

Intersection ID: 52226	Main Street: AMESBURY_HILL_DR	Cross Street: AUBURN_HILL_LN	Location: NE
ADA ID: 7173987F44E4	Ramp Type: Perp	Initial Pass/Fail: Fail	Overall Compliance: No
Codes/Mitigation Info/Possible Solution		Field Measurements/Component Compliance

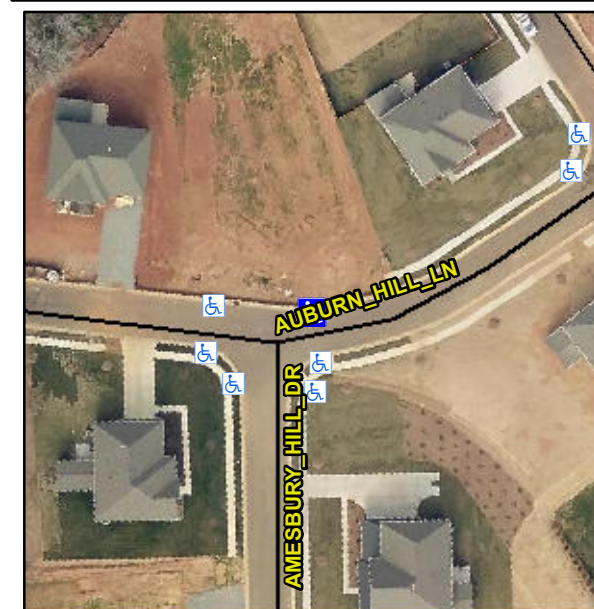
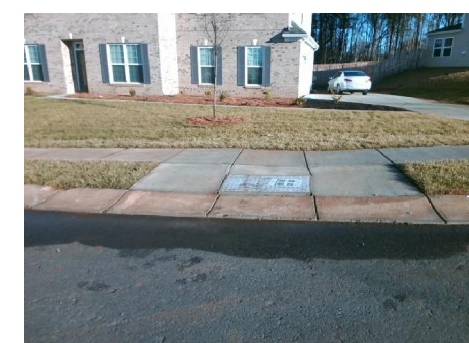
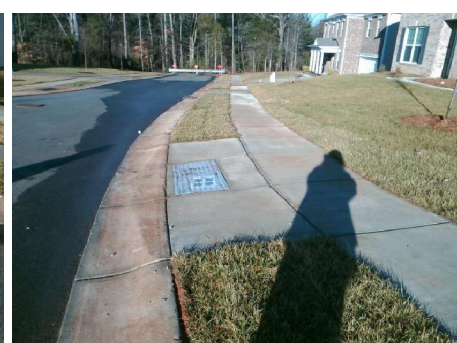
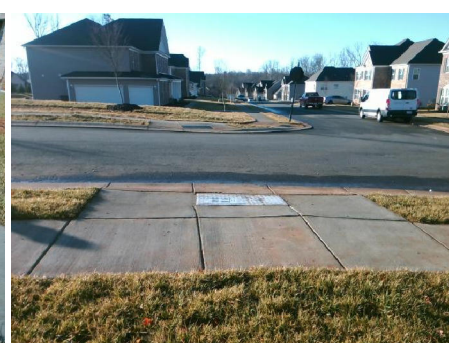
Not Found, R304.5.1, R304.5.3

Compliance	Description	Data	Compliance	Description	Data
N/A	Ramp Length (in)	46.0	Yes	Ramp Slope (%)	6.6
No	Ramp Width (in)	47.0	No	Ramp XSlope (%)	4.3
N/A	Flare Type LT	N/A	N/A	Flare Type RT	N/A
N/A	Flare Slope LT (%)	N/A	N/A	Flare Slope RT (%)	N/A
N/A	Flare Traversable LT?	N/A	N/A	Flare Traversable RT?	N/A
N/A	Landing Length (in)	N/A	N/A	DWS Provided?	N/A
N/A	Landing Width (in)	N/A	N/A	DWS Contrast?	N/A
N/A	Landing Slope (%)	N/A	N/A	DWS Length (in)	N/A
N/A	Landing X Slope (%)	N/A	N/A	DWS Full Width?	N/A
N/A	Landing Curb? (Y/N)	N/A	N/A	DWS Offset (in)	N/A
N/A	Shared Landing?	N/A			
N/A	Gutter Ponding?	N/A	N/A	Gutter Slope (%)	N/A
N/A	Gutter Lip Ht (in)	N/A	N/A	Gutter X Slope (%)	N/A
N/A	Painted X Walk1?	No	N/A	Painted X Walk2?	N/A
	X Walk 1 Direction	To S		X Walk 2 Direction	N/A
N/A	X Walk 1 Width (in)	N/A	N/A	X Walk 2 Width (in)	N/A
	X Walk 1 Slope (%)	2.5		X Walk 2 Slope (%)	N/A
	X Walk 1 X Slope (%)	4.0		X Walk 2 X Slope (%)	N/A

N/A	Ramp inside XWalk1?	N/A	N/A	Ramp inside XWalk2?	N/A
	Road Slope (%)	N/A	N/A	Clear Space?	N/A
	Road X Slope (%)	N/A	N/A	Clear Space to XWalk (in)	N/A
N/A	Any Obstructions?	N/A	N/A	Storm Grate/Utility Hazard?	N/A
	Obstruction Type			Storm Grate/Utility Type	
		N/A			N/A
			Yes	Surface Condition? (G/P)	Good

Remove & Replace Entire Ramp.
