Access Compliance Report Public Rights-of-Way (Curb Ramps)

Intersection ID: 17298 Main Street: IDLEWILD RD **Cross Street: NEW HAMPSHIRE DR** Location: ADA ID: 71757475951B Ramp Type: BlendTrans2 Initial Pass/Fail: Fail **Overall Compliance: No Severity Score:** 10

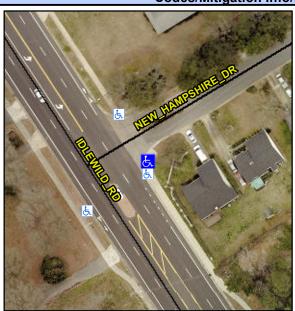
Comp	liance Description	Data	Comp	liance Description	Data
N/A	Ramp Length (in)	90.0	Yes	BlendTrans Slope (%)	3.1
No	Ramp Width (in)	46.5	No	BlendTrans XSlope (%)	2.9
N/A	Flare Type LT	N/A	N/A	Flare Type RT	N/A
N/A	Flare Slope LT (%)	N/A	N/A	Flare Slope RT (%)	N/A
N/A	Flare Traversable LT?	N/A	N/A	Flare Traversable RT?	N/A
N/A	Landing Length (in)	N/A	N/A	DWS Provided?	N/A
N/A	Landing Width (in)	N/A	N/A	DWS Contrast?	N/A
N/A	Landing Slope (%)	N/A	N/A	DWS Length (in)	N/A
N/A	Landing X Slope (%)	N/A	N/A	DWS Full Width?	N/A
N/A	Landing Curb? (Y/N)	N/A	N/A	DWS Offset (in)	N/A
N/A	Shared Landing?	N/A			
N/A	Gutter Ponding?	N/A	N/A	Gutter Slope (%)	N/A
N/A	Gutter Lip Ht (in)	N/A	N/A	Gutter X Slope (%)	N/A
N/A	Painted X Walk1?	No	N/A	Painted X Walk2?	N/A
	X Walk 1 Direction	To NW		X Walk 2 Direction	N/A
	X Walk 1 Width (in)	N/A		X Walk 2 Width (in)	N/A
	X Walk 1 Slope (%)	2.9		X Walk 2 Slope (%)	N/A
	X Walk 1 X Slope (%)	3.5		X Walk 2 X Slope (%)	N/A

N/A	Ramp inside XWalk1?	N/A	N/A	Ramp inside XWalk2?	N/A
	Road Slope (%)	3.5		Clear Space?	N/A
	Road X Slope (%)	2.9	N/A	Clear Space to XWalk (in)	N/A
N/A	Any Obstructions?	N/A	N/A	Storm Grate/Utility Hazard?	N/A
	Obstruction Type		l	Storm Grate/Utility Type	
		N/A			N/A
			Yes	Surface Condition? (G/P)	Good

17. 5-6-4			No	Curb Slope (%)	5.8

NEW HAMPSHIRE DR Street 1 Name Stop Condition-Street 1 StopSign Street 2 Name N/A Stop Condition-Street 2 N/A **Remove & Replace Curb Ramp With Two New Directional Ramps or** Equivalent.

N
			N
Surveyor Notes:			N
N/A			N
			N
			N
			١
PROW/ADA:			N
Not Found,	R304.5.1, R304.5.3		N
•	•		N
			N
			N
Total Cost:	\$	3200.00
