Access Compliance Report Public Rights-of-Way (Curb Ramps)

Intersection ID: 51508	Main Street: ALDERSON_DR			Cross Street: EASTFIELD_RD				Location: E		
ADA ID: 7181BF83E942	42 Ramp Type: Perp			Initial Pass/Fail: Fail Overall Complian			nce: No Severity Score: 22.5		22.5	
Codes/Mitigation Info/Possible Solution			Field Measurements/Component Compliance							
	11/1	Possible Solutions:		Compliance Description Data Compliance Descr				liance Description	Data	
	19/1-	Remove & Replace Entire Ramp		N/A	Ramp Length (in)	187.0	Yes	Ramp Slope (%)	9.4	
A DE CONTRACTOR OF THE OWNER OWNER OF THE OWNER	11 1 15.			No	Ramp Width (in)	47.5	No	Ramp XSlope (%)	2.3	
	111 - 50			N/A	Flare Type LT	N/A	N/A	Flare Type RT	N/A

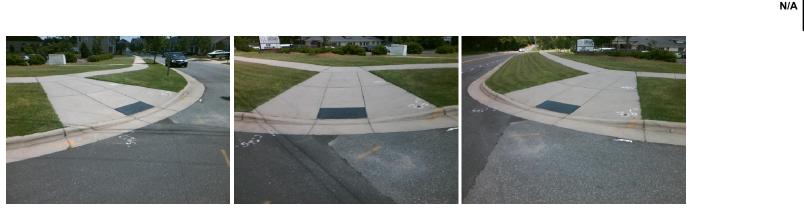
1.14			N/A	Flare Slope LT (%)	N/A	N/A	Flare Slope RT (%)	N/A	
A CARACTER AND A CARACTER ANTER A	119			N/A	Flare Traversable LT?	N/A	N/A	Flare Traversable RT?	N/A	
S S S	3 / 5 /			N/A	Landing Length (in)	N/A	N/A	DWS Provided?	N/A	
	1000	Surveyor Notes:		N/A	Landing Width (in)	N/A	N/A	DWS Contrast?	N/A	
		N/A		N/A	Landing Slope (%)	N/A	N/A	DWS Length (in)	N/A	
				N/A	Landing X Slope (%)	N/A	N/A	DWS Full Width?	N/A	
the second	All.			N/A	Landing Curb? (Y/N)	N/A	N/A	DWS Offset (in)	N/A	
				N/A	Shared Landing?	N/A				
		PROW/ADA:		N/A	Gutter Ponding?	N/A	N/A	Gutter Slope (%)	N/A	
A A A A A A A A A A A A A A A A A A A		R304.5.1, R304.5.3		N/A	Gutter Lip Ht (in)	N/A	N/A	Gutter X Slope (%)	N/A	
	he it is			N/A	Painted X Walk1?	No	N/A	Painted X Walk2?	N/A	
				X Walk 1 Direction	To SW		X Walk 2 Direction	N/A		
CARLAN AND AND AND AND AND AND AND AND AND A				N/A	X Walk 1 Width (in)	N/A	N/A	X Walk 2 Width (in)	N/A

Street 1 Name	ALDERSON DR				X Walk 1 Slope (%)	1.7		X Walk 2 Slope (%)	N/A	
Stop Condition-Street 2	StopSign				X Walk 1 X Slope (%)	0.7		X Walk 2 X Slope (%)	N/A	
Street 2 Name	N/A			N/A	Ramp inside XWalk1?	N/A	N/A	Ramp inside XWalk2?	N/A	
Stop Condition-Street 1	N/A				Road Slope (%)	N/A	N/A	Clear Space?	N/A	
					Road X Slope (%)	N/A	N/A	Clear Space to XWalk (in)	N/A	
				N/A	Any Obstructions?	N/A	N/A	Storm Grate/Utility Hazard?	N/A	
		Total Cost: \$	1850.00		Obstruction Type			Storm Grate/Utility Type		
						N/A			N/A
