Access Compliance Report

Public Rights-of-Way (Curb Ramps)

Intersection ID: 47361	Main Street: PARK_RD	Cross Street: N/A	Location: W
ADA ID: 7183B21F86C3	Ramp Type: Perp	Initial Pass/Fail: Fail	Overall Compliance: No
			Severity Score: 48.75

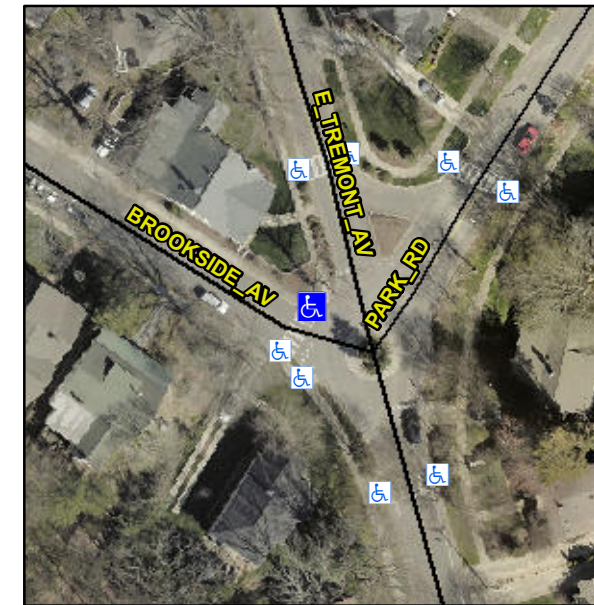
Not Found, R304.5.1, R304.2.2, R304.5.3

Compliance	Description	Data	Compliance	Description	Data
N/A	Ramp Length (in)	49.0	No	Ramp Slope (%)	9.9
No	Ramp Width (in)	30.0	No	Ramp XSlope (%)	3.8
N/A	Flare Type LT	N/A	N/A	Flare Type RT	N/A
N/A	Flare Slope LT (%)	N/A	N/A	Flare Slope RT (%)	N/A
N/A	Flare Traversable LT?	N/A	N/A	Flare Traversable RT?	N/A
N/A	Landing Length (in)	N/A	N/A	DWS Provided?	N/A
N/A	Landing Width (in)	N/A	N/A	DWS Contrast?	N/A
N/A	Landing Slope (%)	N/A	N/A	DWS Length (in)	N/A
N/A	Landing X Slope (%)	N/A	N/A	DWS Full Width?	N/A
N/A	Landing Curb? (Y/N)	N/A	N/A	DWS Offset (in)	N/A
N/A	Shared Landing?	N/A			
N/A	Gutter Ponding?	N/A	N/A	Gutter Slope (%)	N/A
N/A	Gutter Lip Ht (in)	N/A	N/A	Gutter X Slope (%)	N/A
N/A	Painted X Walk1?	Yes	N/A	Painted X Walk2?	N/A
	X Walk 1 Direction	To SW		X Walk 2 Direction	N/A
N/A	X Walk 1 Width (in)	104.0	N/A	X Walk 2 Width (in)	N/A
	X Walk 1 Slope (%)	0.3		X Walk 2 Slope (%)	N/A
	X Walk 1 X Slope (%)	5.4		X Walk 2 X Slope (%)	N/A

N/A	Ramp inside XWalk1?	Yes	N/A	Ramp inside XWalk2?	N/A
	Road Slope (%)	N/A	N/A	Clear Space?	N/A
	Road X Slope (%)	N/A	N/A	Clear Space to XWalk (in)	N/A
N/A	Any Obstructions?	N/A	N/A	Storm Grate/Utility Hazard?	N/A
	Obstruction Type			Storm Grate/Utility Type	
		N/A			N/A
			Yes	Surface Condition? (G/P)	Good

Remove & Replace Entire Ramp.
