Access Compliance Report

Public Rights-of-Way

(Curb Ramps)

Intersection ID: 3612	Main Street: BRIDLE_RIDGE_LN	Cross Street: FURLONG_TL	Location: SE
ADA ID: 7185AC474E58	Ramp Type: Perp	Initial Pass/Fail: Fail	Overall Compliance: No
		Severity Score: 35

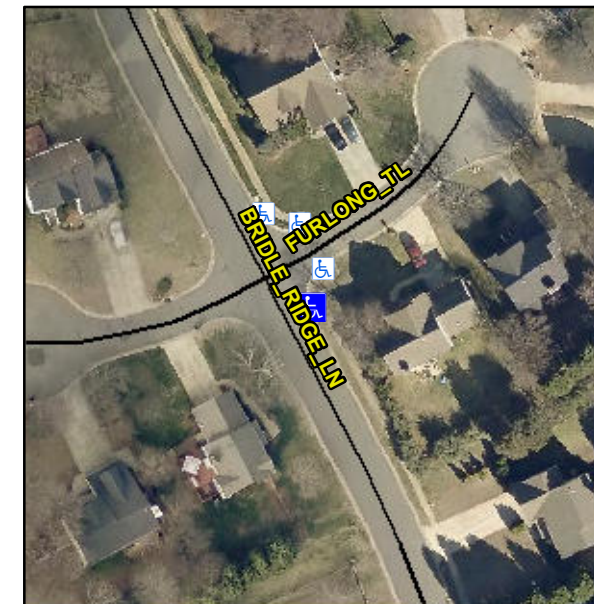
Not Found, R304.5.1, R304.2.2, R304.5.3

Compliance	Description	Data	Compliance	Description	Data
N/A	Ramp Length (in)	50.0	No	Ramp Slope (%)	15.4
No	Ramp Width (in)	45.0	No	Ramp XSlope (%)	4.8
N/A	Flare Type LT	N/A	N/A	Flare Type RT	N/A
N/A	Flare Slope LT (%)	N/A	N/A	Flare Slope RT (%)	N/A
N/A	Flare Traversable LT?	N/A	N/A	Flare Traversable RT?	N/A
N/A	Landing Length (in)	N/A	N/A	DWS Provided?	N/A
N/A	Landing Width (in)	N/A	N/A	DWS Contrast?	N/A
N/A	Landing Slope (%)	N/A	N/A	DWS Length (in)	N/A
N/A	Landing X Slope (%)	N/A	N/A	DWS Full Width?	N/A
N/A	Landing Curb? (Y/N)	N/A	N/A	DWS Offset (in)	N/A
N/A	Shared Landing?	N/A			
N/A	Gutter Ponding?	N/A	N/A	Gutter Slope (%)	N/A
N/A	Gutter Lip Ht (in)	N/A	N/A	Gutter X Slope (%)	N/A
N/A	Painted X Walk1?	No	N/A	Painted X Walk2?	N/A
	X Walk 1 Direction	To SW		X Walk 2 Direction	N/A
N/A	X Walk 1 Width (in)	N/A	N/A	X Walk 2 Width (in)	N/A
	X Walk 1 Slope (%)	4.0		X Walk 2 Slope (%)	N/A
	X Walk 1 X Slope (%)	4.6		X Walk 2 X Slope (%)	N/A

N/A	Ramp inside XWalk1?	N/A	N/A	Ramp inside XWalk2?	N/A
	Road Slope (%)	N/A	N/A	Clear Space?	N/A
	Road X Slope (%)	N/A	N/A	Clear Space to XWalk (in)	N/A
N/A	Any Obstructions?	N/A	N/A	Storm Grate/Utility Hazard?	N/A
	Obstruction Type			Storm Grate/Utility Type	
		N/A			N/A
			Yes	Surface Condition? (G/P)	Good

Remove & Replace Entire Ramp.
