# Access Compliance Report

## Public Rights-of-Way

### (Curb Ramps)

Intersection ID: 10029825	Main Street: KREFELD_DR	Cross Street: N/A	Location: NW
ADA ID: 7192E6E63C5E	Ramp Type: PerpDiag	Initial Pass/Fail: Fail	Overall Compliance: No
		Severity Score: 10

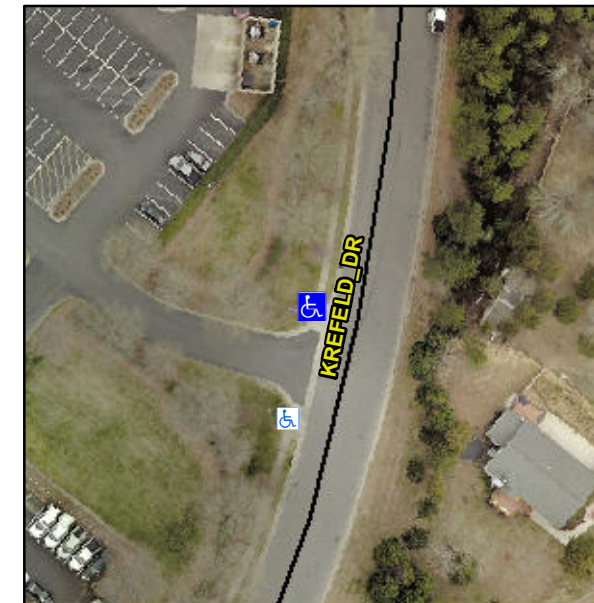
**Not Found, R304.5.1, R304.5.3**

Compliance	Description	Data	Compliance	Description	Data
N/A	Ramp Length (in)	94.0	Yes	Ramp Slope (%)	6.8
No	Ramp Width (in)	36.0	No	Ramp XSlope (%)	4.6
N/A	Flare Type LT	N/A	N/A	Flare Type RT	N/A
N/A	Flare Slope LT (%)	N/A	N/A	Flare Slope RT (%)	N/A
N/A	Flare Traversable LT?	N/A	N/A	Flare Traversable RT?	N/A
N/A	Landing Length (in)	N/A	N/A	DWS Provided?	N/A
N/A	Landing Width (in)	N/A	N/A	DWS Contrast?	N/A
N/A	Landing Slope (%)	N/A	N/A	DWS Length (in)	N/A
N/A	Landing X Slope (%)	N/A	N/A	DWS Full Width?	N/A
N/A	Landing Curb? (Y/N)	N/A	N/A	DWS Offset (in)	N/A
N/A	Shared Landing?	N/A			
N/A	Gutter Ponding?	N/A	N/A	Gutter Slope (%)	N/A
N/A	Gutter Lip Ht (in)	N/A	N/A	Gutter X Slope (%)	N/A
N/A	Painted X Walk1?	No	N/A	Painted X Walk2?	No
	X Walk 1 Direction	To S		X Walk 2 Direction	To E
N/A	X Walk 1 Width (in)	N/A	N/A	X Walk 2 Width (in)	N/A
	X Walk 1 Slope (%)	0.1		X Walk 2 Slope (%)	10.2
	X Walk 1 X Slope (%)	5.7		X Walk 2 X Slope (%)	1.4

N/A	Ramp inside XWalk1?	N/A	N/A	Ramp inside XWalk2?	N/A
	Road Slope (%)	5.1	N/A	Clear Space?	N/A
	Road X Slope (%)	6.5	N/A	Clear Space to XWalk (in)	N/A
N/A	Any Obstructions?	N/A	N/A	Storm Grate/Utility Hazard?	N/A
	Obstruction Type			Storm Grate/Utility Type	
		N/A			N/A
			Yes	Surface Condition? (G/P)	Good

**Remove & Replace Curb Ramp With Two New Directional Ramps or Equivalent.**
