# Access Compliance Report

## Public Rights-of-Way

### (Curb Ramps)

Intersection ID: 23944	Main Street: BOSHAM_LN	Cross Street: PRESCOTT_POND_LN	Location: N
ADA ID: 719E9A924922	Ramp Type: Perp	Initial Pass/Fail: Fail	Overall Compliance: No
Severity Score: 21.25			
Codes/Mitigation Info/Possible Solution		Field Measurements/Component Compliance

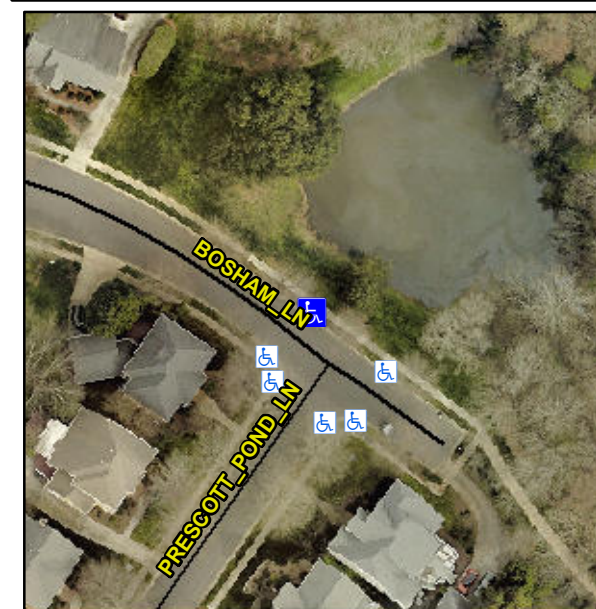
**Not Found, R304.5.1, R304.2.2**

Compliance	Description	Data	Compliance	Description	Data
N/A	Ramp Length (in)	47.0	No	Ramp Slope (%)	8.4
No	Ramp Width (in)	47.0	Yes	Ramp XSlope (%)	1.4
N/A	Flare Type LT	N/A	N/A	Flare Type RT	N/A
N/A	Flare Slope LT (%)	N/A	N/A	Flare Slope RT (%)	N/A
N/A	Flare Traversable LT?	N/A	N/A	Flare Traversable RT?	N/A
N/A	Landing Length (in)	N/A	N/A	DWS Provided?	N/A
N/A	Landing Width (in)	N/A	N/A	DWS Contrast?	N/A
N/A	Landing Slope (%)	N/A	N/A	DWS Length (in)	N/A
N/A	Landing X Slope (%)	N/A	N/A	DWS Full Width?	N/A
N/A	Landing Curb? (Y/N)	N/A	N/A	DWS Offset (in)	N/A
N/A	Shared Landing?	N/A			
N/A	Gutter Ponding?	N/A	N/A	Gutter Slope (%)	N/A
N/A	Gutter Lip Ht (in)	N/A	N/A	Gutter X Slope (%)	N/A
N/A	Painted X Walk1?	No	N/A	Painted X Walk2?	N/A
	X Walk 1 Direction	To SW		X Walk 2 Direction	N/A
N/A	X Walk 1 Width (in)	N/A	N/A	X Walk 2 Width (in)	N/A
	X Walk 1 Slope (%)	3.3		X Walk 2 Slope (%)	N/A
	X Walk 1 X Slope (%)	1.0		X Walk 2 X Slope (%)	N/A

N/A	Ramp inside XWalk1?	N/A	N/A	Ramp inside XWalk2?	N/A
	Road Slope (%)	N/A	N/A	Clear Space?	N/A
	Road X Slope (%)	N/A	N/A	Clear Space to XWalk (in)	N/A
N/A	Any Obstructions?	N/A	N/A	Storm Grate/Utility Hazard?	N/A
	Obstruction Type			Storm Grate/Utility Type	
		N/A			N/A
			Yes	Surface Condition? (G/P)	Good

**Remove & Replace Entire Ramp.**

Total Cost: \$ 1850.00
