Access Compliance Report Public Rights-of-Way (Curb Ramps)

Intersection ID: 27254Main Street:PIPER_STATION_DRCross Street:SPINDLETOP_PLLocation:NEADA ID: 71A0952E73B6Ramp Type:PerpInitial Pass/Fail:FailOverall Compliance:NoSeverity Score:21.25

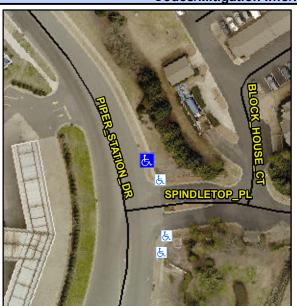
Not Found, R304.5.1, R304.2.2

Compliance Description Data Compliance Description Data					
N/A Ramp Length (in)		95.0	No	Ramp Slope (%)	8.4
No No	Ramp Width (in)	44.5	Yes	Ramp XSlope (%)	0.4
N/A	. , ,	44.5 N/A	N/A	,	N/A
N/A	Flare Type LT		N/A N/A	Flare Clare BT (%)	
	Flare Slope LT (%)	N/A	l	Flare Slope RT (%)	N/A
N/A	Flare Traversable LT?	N/A	N/A	Flare Traversable RT?	N/A
N/A	Landing Length (in)	N/A	N/A	DWS Provided?	N/A
N/A	Landing Width (in)	N/A	N/A	DWS Contrast?	N/A
N/A	Landing Slope (%)	N/A	N/A	DWS Length (in)	N/A
N/A	Landing X Slope (%)	N/A	N/A	DWS Full Width?	N/A
N/A	Landing Curb? (Y/N)	N/A	N/A	DWS Offset (in)	N/A
N/A	Shared Landing?	N/A			
N/A	Gutter Ponding?	N/A	N/A	Gutter Slope (%)	N/A
N/A	Gutter Lip Ht (in)	N/A	N/A	Gutter X Slope (%)	N/A
N/A	Painted X Walk1?	No	N/A	Painted X Walk2?	N/A
	X Walk 1 Direction	To W		X Walk 2 Direction	N/A
N/A	X Walk 1 Width (in)	N/A	N/A	X Walk 2 Width (in)	N/A
	X Walk 1 Slope (%)	2.5		X Walk 2 Slope (%)	N/A

X Walk 1 X Slope (%)	0.1		X Walk 2 X Slope (%)	N/A
N/A	Ramp inside XWalk1?	N/A	N/A	Ramp inside XWalk2?	N/A
	Road Slope (%)	N/A	N/A	Clear Space?	N/A
	Road X Slope (%)	N/A	N/A	Clear Space to XWalk (in)	N/A
N/A	Any Obstructions?	N/A	N/A	Storm Grate/Utility Hazard?	N/A
	Obstruction Type		l	Storm Grate/Utility Type	
		N/A			N/A
			Yes	Surface Condition? (G/P)	Good
50°	- Maker	'	•	,

Remove & Replace Entire Ramp.

Total Cost: \$ 1850.00
