Access Compliance Report Public Rights-of-Way (Curb Ramps)

Intersection ID: 16793 Main Street: MILL CREEK LN **Cross Street: SELWYN FARMS LN** Location: SW ADA ID: 71A549940982 Ramp Type: PerpDiag Initial Pass/Fail: Pass **Overall Compliance: No** Severity Score: 10.25

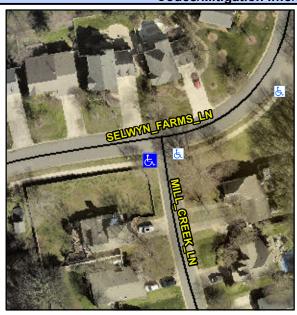
| Freid Measurements/Component Compliance | | | | | |
|---|--|---|---|---|---|
| Yes | Ramp Width (in) | 48.0 | No | Ramp XSlope (%) | 2.8 |
| No | Landing Length (in) | N/A | Yes | DWS Provided? | Yes |
| No | Landing Width (in) | N/A | Yes | DWS Contrast? | Yes |
| No | Landing Slope (%) | N/A | Yes | DWS Length (in) | 24.0 |
| No | Landing X Slope (%) | N/A | Yes | DWS Full Width? | Yes |
| N/A | Landing Curb? (Y/N) | No | No | DWS Offset (in) | 3.5 |
| Yes | Gutter Lip Ht (in) | 0.0 | No | Gutter X Slope (%) | 3.8 |

Possible Solutions: Remove & Replace Curb Ramp With Two New Directional Ramps or Equivalent. Remove & Replace Gutter. Surveyor Notes: N/A PROW/ADA:

Not Found, R304.5.3, R304.2.1, R304.2.2-Perp, R304.3.2-Para, R305.2
