Access Compliance Report

Public Rights-of-Way

(Curb Ramps)

Intersection ID: 51379	Main Street: BROADRICK_BV	Cross Street: UNIVERSITY_CITY_BV	Location: S
ADA ID: 71A5ED10FB4A	Ramp Type: Perp	Initial Pass/Fail: Fail	Overall Compliance: No
Severity Score: 25			
Codes/Mitigation Info/Possible Solution		Field Measurements/Component Compliance

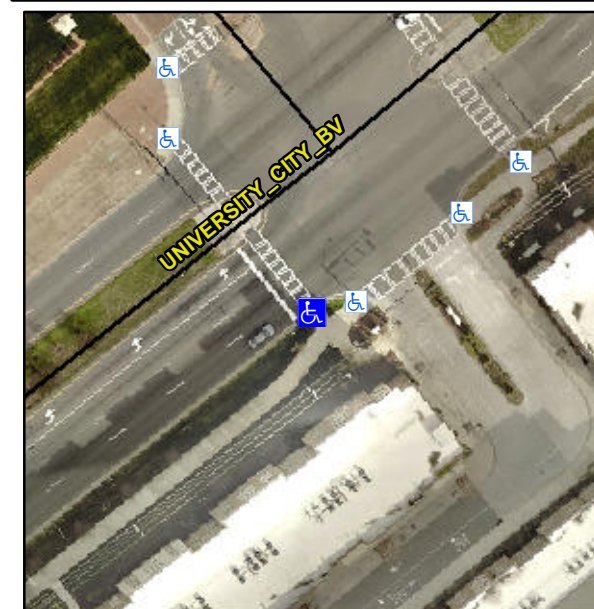
Not Found, R304.2.2

Compliance	Description	Data	Compliance	Description	Data
N/A	Ramp Length (in)	85.0	No	Ramp Slope (%)	17.1
Yes	Ramp Width (in)	93.5	Yes	Ramp XSlope (%)	1.6
N/A	Flare Type LT	N/A	N/A	Flare Type RT	N/A
N/A	Flare Slope LT (%)	N/A	N/A	Flare Slope RT (%)	N/A
N/A	Flare Traversable LT?	N/A	N/A	Flare Traversable RT?	N/A
N/A	Landing Length (in)	N/A	N/A	DWS Provided?	N/A
N/A	Landing Width (in)	N/A	N/A	DWS Contrast?	N/A
N/A	Landing Slope (%)	N/A	N/A	DWS Length (in)	N/A
N/A	Landing X Slope (%)	N/A	N/A	DWS Full Width?	N/A
N/A	Landing Curb? (Y/N)	N/A	N/A	DWS Offset (in)	N/A
N/A	Shared Landing?	N/A			
N/A	Gutter Ponding?	N/A	N/A	Gutter Slope (%)	N/A
N/A	Gutter Lip Ht (in)	N/A	N/A	Gutter X Slope (%)	N/A
N/A	Painted X Walk1?	Yes	N/A	Painted X Walk2?	N/A
	X Walk 1 Direction	To NW		X Walk 2 Direction	N/A
N/A	X Walk 1 Width (in)	79.0	N/A	X Walk 2 Width (in)	N/A
	X Walk 1 Slope (%)	3.8		X Walk 2 Slope (%)	N/A
	X Walk 1 X Slope (%)	4.0		X Walk 2 X Slope (%)	N/A

Remove & Replace Entire Ramp.
