# Access Compliance Report

## Public Rights-of-Way

### (Curb Ramps)

Intersection ID: 5192	Main Street: CARRONBRIDGE_LN	Cross Street: SOUTHMINSTER_LN	Location:	N
ADA ID: 71AF28AEB2B9	Ramp Type: BlendTrans1	Initial Pass/Fail: Pass	Overall Compliance: No	Severity Score: 7.75

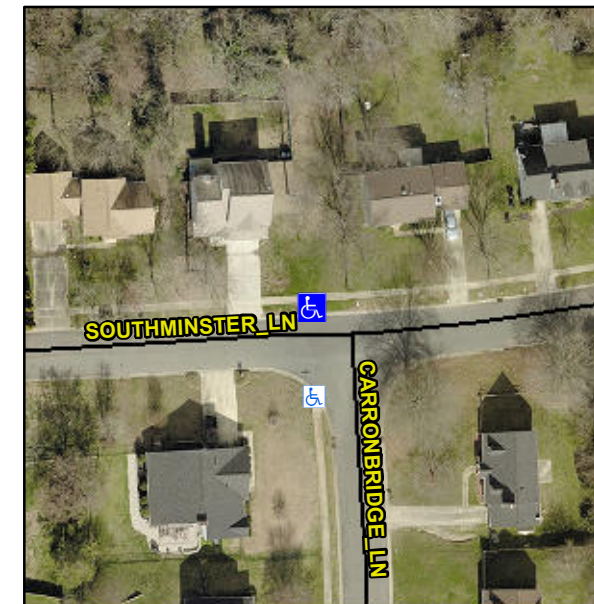
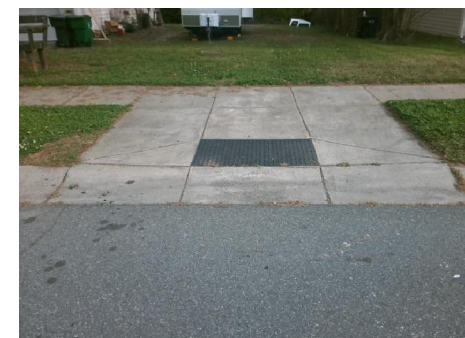
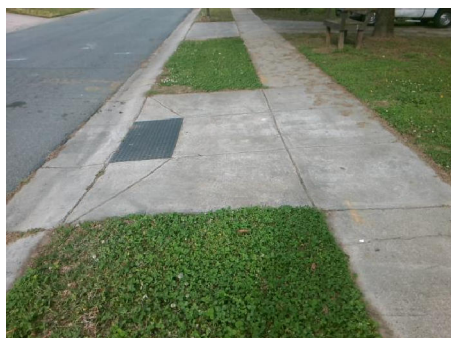
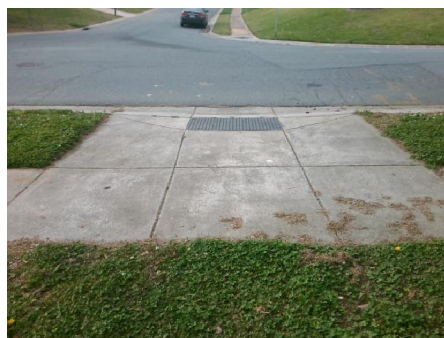
**Not Found, R304.5.3, R304.2.1, R302.7.2**

Compliance	Description	Data	Compliance	Description	Data
N/A	Ramp Length (in)	24.0	Yes	BlendTrans Slope (%)	5.0
Yes	Ramp Width (in)	48.0	No	BlendTrans XSlope (%)	3.1
N/A	Flare Type LT	Sloped	N/A	Flare Type RT	Sloped
Yes	Flare Slope LT (%)	5.6	Yes	Flare Slope RT (%)	0.0
N/A	Flare Traversable LT?	Yes	N/A	Flare Traversable RT?	Yes
No	Landing Length (in)	46.0	Yes	DWS Provided?	Yes
Yes	Landing Width (in)	48.0	Yes	DWS Contrast?	Yes
Yes	Landing Slope (%)	1.9	Yes	DWS Length (in)	24.0
No	Landing X Slope (%)	4.2	Yes	DWS Full Width?	Yes
N/A	Landing Curb? (Y/N)	No	Yes	DWS Offset (in)	0.0
N/A	Shared Landing?	No			
Yes	Gutter Ponding?	No	Yes	Gutter Slope (%)	4.7
No	Gutter Lip Ht (in)	0.5	Yes	Gutter X Slope (%)	2.6
N/A	Painted X Walk1?	No	N/A	Painted X Walk2?	N/A
	X Walk 1 Direction	To S		X Walk 2 Direction	N/A
	X Walk 1 Width (in)	N/A		X Walk 2 Width (in)	N/A
	X Walk 1 Slope (%)	1.9		X Walk 2 Slope (%)	N/A
	X Walk 1 X Slope (%)	2.7		X Walk 2 X Slope (%)	N/A

N/A	Ramp inside XWalk1?	N/A	N/A	Ramp inside XWalk2?	N/A
	Road Slope (%)	2.7		Clear Space?	Yes
	Road X Slope (%)	1.9	N/A	Clear Space to XWalk (in)	N/A
Yes	Any Obstructions?	No	Yes	Storm Grate/Utility Hazard?	No
	Obstruction Type			Storm Grate/Utility Type	
			N/A		N/A
			Yes	Surface Condition? (G/P)	Good
			No	Curb Slope (%)	11.5

**Remove & Replace Curb Ramp With Two New Directional Ramps or Equivalent.**
