Access Compliance Report

Public Rights-of-Way

| Intersection ID: 24261 | Main Street: REA_RD | Cross Street: CHADWYCK_FARMS_DR | Location: E |
| ADA ID: 71AF3CE595E2 | Ramp Type: PerpDiag | Initial Pass/Fail: Fail | Overall Compliance: No |

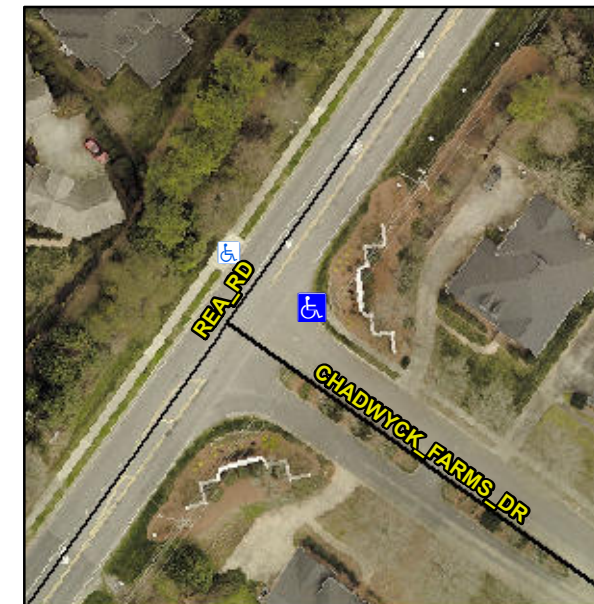
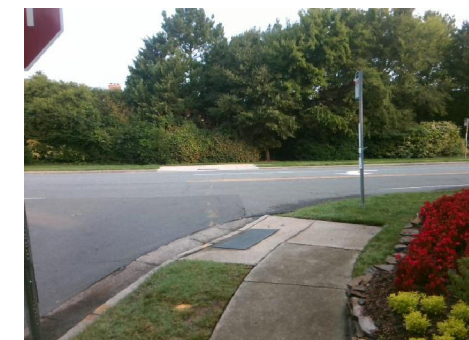
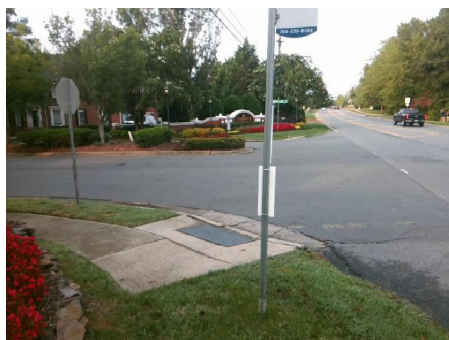
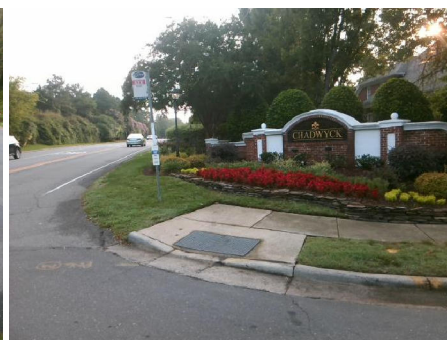
| Severity Score: 37.5 | | | |

| Compliance | Description | Data | Compliance | Description | Data |
|---|---|---|---|---|---|
| N/A | Ramp Length (in) | 48.0 | No | Ramp Slope (%) | 11.4 |
| Yes | Ramp Width (in) | 48.0 | No | Ramp XSlope (%) | 7.0 |

Remove & Replace Curb Ramp With Two New Directional Ramps or Equivalent.

R304.2.2, R304.5.3
