Access Compliance Report

Public Rights-of-Way

(Curb Ramps)

Intersection ID: 21723	Main Street: BALLENCOURT_LN	Cross Street: COLONY_RD	Location: NE
ADA ID: 71B4265E9F95	Ramp Type: PerpDiag	Initial Pass/Fail: Fail	Overall Compliance: No
Severity Score: 12.5			
Codes/Mitigation Info/Possible Solution		Field Measurements/Component Compliance

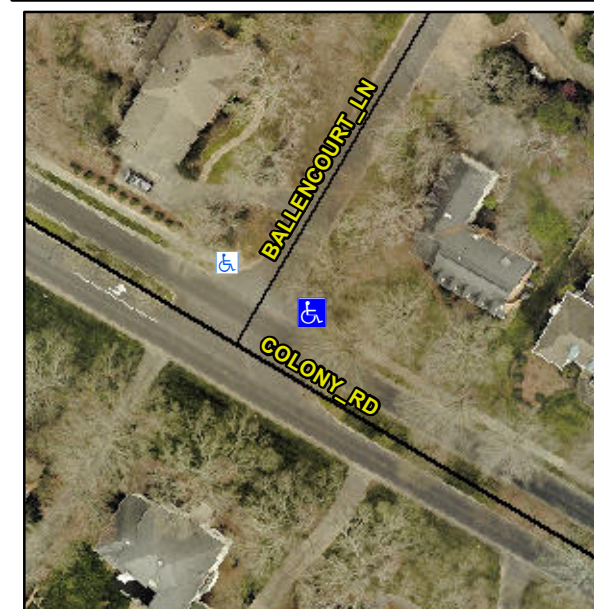
Not Found, R304.2.2

Compliance	Description	Data	Compliance	Description	Data
N/A	Ramp Length (in)	56.0	No	Ramp Slope (%)	9.6
Yes	Ramp Width (in)	48.0	Yes	Ramp XSlope (%)	1.2
N/A	Flare Type LT	N/A	N/A	Flare Type RT	N/A
N/A	Flare Slope LT (%)	N/A	N/A	Flare Slope RT (%)	N/A
N/A	Flare Traversable LT?	N/A	N/A	Flare Traversable RT?	N/A
N/A	Landing Length (in)	N/A	N/A	DWS Provided?	N/A
N/A	Landing Width (in)	N/A	N/A	DWS Contrast?	N/A
N/A	Landing Slope (%)	N/A	N/A	DWS Length (in)	N/A
N/A	Landing X Slope (%)	N/A	N/A	DWS Full Width?	N/A
N/A	Landing Curb? (Y/N)	N/A	N/A	DWS Offset (in)	N/A
N/A	Shared Landing?	N/A			
N/A	Gutter Ponding?	N/A	N/A	Gutter Slope (%)	N/A
N/A	Gutter Lip Ht (in)	N/A	N/A	Gutter X Slope (%)	N/A
N/A	Painted X Walk1?	No	N/A	Painted X Walk2?	No
	X Walk 1 Direction	To NW		X Walk 2 Direction	To SW
N/A	X Walk 1 Width (in)	N/A	N/A	X Walk 2 Width (in)	N/A
	X Walk 1 Slope (%)	0.6		X Walk 2 Slope (%)	3.3
	X Walk 1 X Slope (%)	5.5		X Walk 2 X Slope (%)	3.6

N/A	Ramp inside XWalk1?	N/A	N/A	Ramp inside XWalk2?	N/A
	Road Slope (%)	1.4	N/A	Clear Space?	N/A
	Road X Slope (%)	4.4	N/A	Clear Space to XWalk (in)	N/A
N/A	Any Obstructions?	N/A	N/A	Storm Grate/Utility Hazard?	N/A
	Obstruction Type			Storm Grate/Utility Type	
		N/A			N/A
			Yes	Surface Condition? (G/P)	Good

Remove & Replace Curb Ramp With Two New Directional Ramps or Equivalent.

Total Cost: \$ 3200.00
