Access Compliance Report

Public Rights-of-Way

(Curb Ramps)

Intersection ID: N/A	Main Street: NEW_FASHION_WY	Cross Street: N/A	Location: W
ADA ID: 71B9D278FF6C	Ramp Type: Perp	Initial Pass/Fail: Fail	Overall Compliance: No
Severity Score: 13.75			
Codes/Mitigation Info/Possible Solution		Field Measurements/Component Compliance

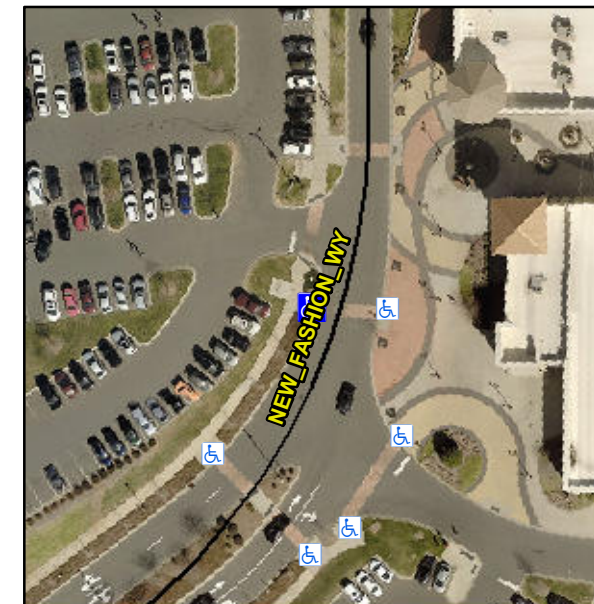
Compliance	Description	Data	Compliance	Description	Data
N/A	Ramp Length (in)	94.0	No	Ramp Slope (%)	8.8
Yes	Ramp Width (in)	114.0	No	Ramp XSlope (%)	3.5
N/A	Flare Type LT	N/A	N/A	Flare Type RT	N/A
N/A	Flare Slope LT (%)	N/A	N/A	Flare Slope RT (%)	N/A
N/A	Flare Traversable LT?	N/A	N/A	Flare Traversable RT?	N/A
N/A	Landing Length (in)	N/A	N/A	DWS Provided?	N/A
N/A	Landing Width (in)	N/A	N/A	DWS Contrast?	N/A
N/A	Landing Slope (%)	N/A	N/A	DWS Length (in)	N/A
N/A	Landing X Slope (%)	N/A	N/A	DWS Full Width?	N/A
N/A	Landing Curb? (Y/N)	N/A	N/A	DWS Offset (in)	N/A
N/A	Shared Landing?	N/A			
N/A	Gutter Ponding?	N/A	N/A	Gutter Slope (%)	N/A
N/A	Gutter Lip Ht (in)	N/A	N/A	Gutter X Slope (%)	N/A
N/A	Painted X Walk1?	Yes	N/A	Painted X Walk2?	N/A
	X Walk 1 Direction	To E		X Walk 2 Direction	N/A
N/A	X Walk 1 Width (in)	80.0	N/A	X Walk 2 Width (in)	N/A
	X Walk 1 Slope (%)	1.5		X Walk 2 Slope (%)	N/A
	X Walk 1 X Slope (%)	2.3		X Walk 2 X Slope (%)	N/A

N/A	Ramp inside XWalk1?	Yes	N/A	Ramp inside XWalk2?	N/A
	Road Slope (%)	N/A	N/A	Clear Space?	N/A
	Road X Slope (%)	N/A	N/A	Clear Space to XWalk (in)	N/A
N/A	Any Obstructions?	N/A	N/A	Storm Grate/Utility Hazard?	N/A
	Obstruction Type			Storm Grate/Utility Type	
		N/A			N/A
			Yes	Surface Condition? (G/P)	Good

Possible Solutions:

Remove & Replace Entire Ramp.

R304.2.2, R304.5.3
