# Access Compliance Report

## Public Rights-of-Way

### (Curb Ramps)

Intersection ID: 7876	Main Street: BROOKTREE_DR	Cross Street: N/A	Location: SE
ADA ID: 71BBE5F52113	Ramp Type: BlendTrans2	Initial Pass/Fail: Fail	Overall Compliance: No
		Severity Score: 8.75	
Codes/Mitigation Info/Possible Solution		Field Measurements/Component Compliance

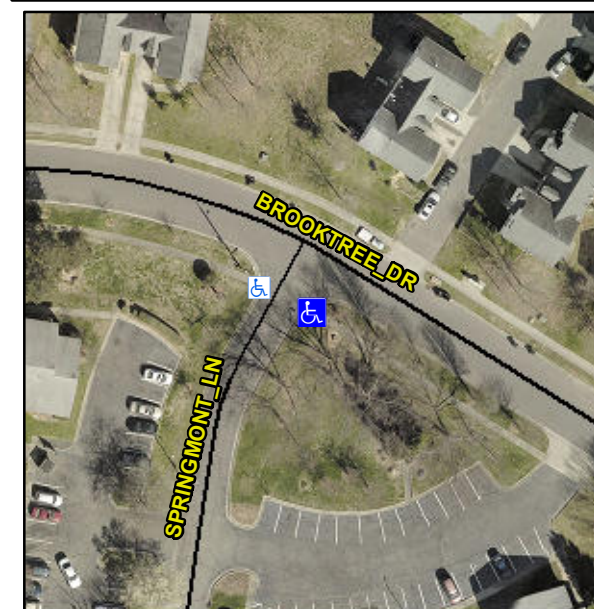
Compliance	Description	Data	Compliance	Description	Data
N/A	Ramp Length (in)	41.0	Yes	BlendTrans Slope (%)	2.1
No	Ramp Width (in)	47.5	Yes	BlendTrans XSlope (%)	1.9
N/A	Flare Type LT	N/A	N/A	Flare Type RT	N/A
N/A	Flare Slope LT (%)	N/A	N/A	Flare Slope RT (%)	N/A
N/A	Flare Traversable LT?	N/A	N/A	Flare Traversable RT?	N/A
N/A	Landing Length (in)	N/A	N/A	DWS Provided?	N/A
N/A	Landing Width (in)	N/A	N/A	DWS Contrast?	N/A
N/A	Landing Slope (%)	N/A	N/A	DWS Length (in)	N/A
N/A	Landing X Slope (%)	N/A	N/A	DWS Full Width?	N/A
N/A	Landing Curb? (Y/N)	N/A	N/A	DWS Offset (in)	N/A
N/A	Shared Landing?	N/A			
N/A	Gutter Ponding?	N/A	N/A	Gutter Slope (%)	N/A
N/A	Gutter Lip Ht (in)	N/A	N/A	Gutter X Slope (%)	N/A
N/A	Painted X Walk1?	No	N/A	Painted X Walk2?	N/A
	X Walk 1 Direction	To NW		X Walk 2 Direction	N/A
	X Walk 1 Width (in)	N/A		X Walk 2 Width (in)	N/A
	X Walk 1 Slope (%)	7.3		X Walk 2 Slope (%)	N/A
	X Walk 1 X Slope (%)	3.8		X Walk 2 X Slope (%)	N/A

N/A	Ramp inside XWalk1?	N/A	N/A	Ramp inside XWalk2?	N/A
	Road Slope (%)	3.8		Clear Space?	N/A
	Road X Slope (%)	7.3	N/A	Clear Space to XWalk (in)	N/A
N/A	Any Obstructions?	N/A	N/A	Storm Grate/Utility Hazard?	N/A
	Obstruction Type			Storm Grate/Utility Type	
		N/A			N/A
			Yes	Surface Condition? (G/P)	Good
			N/A	Curb Slope (%)	0.3

**Remove & Replace Curb Ramp With Two New Directional Ramps or Equivalent.**

**R304.5.1**
