# Access Compliance Report

## Public Rights-of-Way

### (Curb Ramps)

Intersection ID: 20284	Main Street: LANSLOWNE_RD	Cross Street: MORVEN_LN	Location: S
ADA ID: 71BFCC9D5836	Ramp Type: PerpDiag	Initial Pass/Fail: Fail	Overall Compliance: No
		Severity Score: 1.25

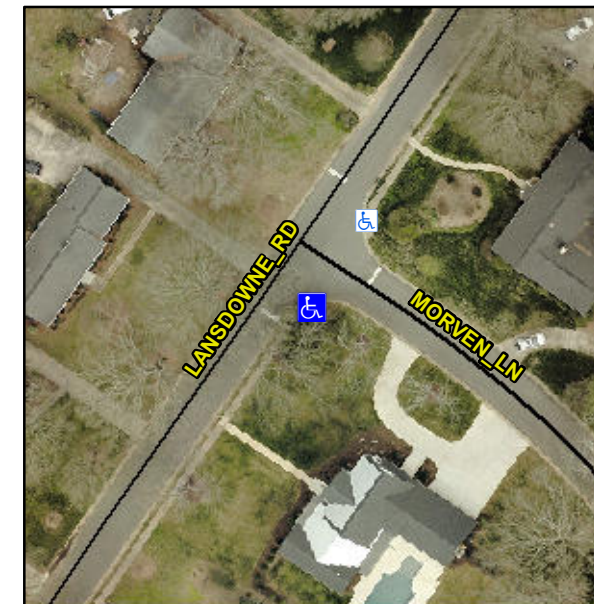
**Not Found, R304.5.3**

Compliance	Description	Data	Compliance	Description	Data
N/A	Ramp Length (in)	50.0	Yes	Ramp Slope (%)	8.1
Yes	Ramp Width (in)	50.0	No	Ramp XSlope (%)	2.8
N/A	Flare Type LT	N/A	N/A	Flare Type RT	N/A
N/A	Flare Slope LT (%)	N/A	N/A	Flare Slope RT (%)	N/A
N/A	Flare Traversable LT?	N/A	N/A	Flare Traversable RT?	N/A
N/A	Landing Length (in)	N/A	N/A	DWS Provided?	N/A
N/A	Landing Width (in)	N/A	N/A	DWS Contrast?	N/A
N/A	Landing Slope (%)	N/A	N/A	DWS Length (in)	N/A
N/A	Landing X Slope (%)	N/A	N/A	DWS Full Width?	N/A
N/A	Landing Curb? (Y/N)	N/A	N/A	DWS Offset (in)	N/A
N/A	Shared Landing?	N/A			
N/A	Gutter Ponding?	N/A	N/A	Gutter Slope (%)	N/A
N/A	Gutter Lip Ht (in)	N/A	N/A	Gutter X Slope (%)	N/A
N/A	Painted X Walk1?	No	N/A	Painted X Walk2?	No
	X Walk 1 Direction	To NE		X Walk 2 Direction	To NW
N/A	X Walk 1 Width (in)	N/A	N/A	X Walk 2 Width (in)	N/A
	X Walk 1 Slope (%)	3.0		X Walk 2 Slope (%)	4.3
	X Walk 1 X Slope (%)	3.2		X Walk 2 X Slope (%)	2.1

N/A	Ramp inside XWalk1?	N/A	N/A	Ramp inside XWalk2?	N/A
	Road Slope (%)	1.0	N/A	Clear Space?	N/A
	Road X Slope (%)	3.7	N/A	Clear Space to XWalk (in)	N/A
N/A	Any Obstructions?	N/A	N/A	Storm Grate/Utility Hazard?	N/A
	Obstruction Type			Storm Grate/Utility Type	
		N/A			N/A
			Yes	Surface Condition? (G/P)	Good

**Remove & Replace Curb Ramp With Two New Directional Ramps or Equivalent.**

Total Cost: \$ 3200.00
