Access Compliance Report

Public Rights-of-Way

(Curb Ramps)

Intersection ID: 11357	Main Street: W_TRADE_ST	Cross Street: N_IRWIN_AV	Location: SW
ADA ID: 71CA80F5D8C3	Ramp Type: Perp	Initial Pass/Fail: Fail	Overall Compliance: No
Severity Score: 25			
Codes/Mitigation Info/Possible Solution		Field Measurements/Component Compliance

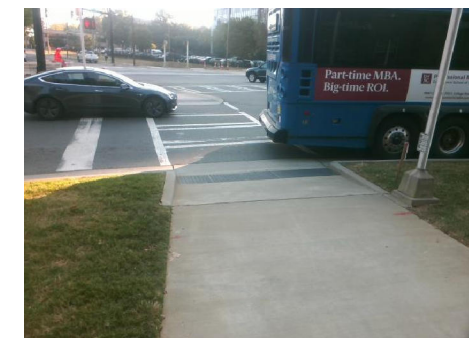
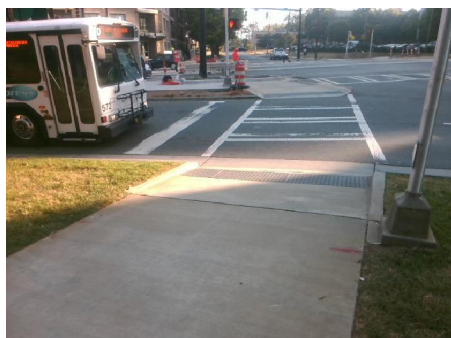
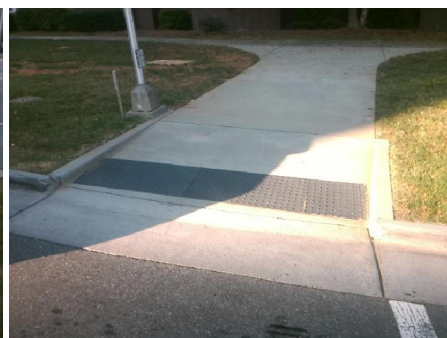
Not Found, R304.2.2, R304.5.3

Compliance	Description	Data	Compliance	Description	Data
N/A	Ramp Length (in)	72.0	No	Ramp Slope (%)	9.2
Yes	Ramp Width (in)	120.0	No	Ramp XSlope (%)	5.2
N/A	Flare Type LT	N/A	N/A	Flare Type RT	N/A
N/A	Flare Slope LT (%)	N/A	N/A	Flare Slope RT (%)	N/A
N/A	Flare Traversable LT?	N/A	N/A	Flare Traversable RT?	N/A
N/A	Landing Length (in)	N/A	N/A	DWS Provided?	N/A
N/A	Landing Width (in)	N/A	N/A	DWS Contrast?	N/A
N/A	Landing Slope (%)	N/A	N/A	DWS Length (in)	N/A
N/A	Landing X Slope (%)	N/A	N/A	DWS Full Width?	N/A
N/A	Landing Curb? (Y/N)	N/A	N/A	DWS Offset (in)	N/A
N/A	Shared Landing?	N/A			
N/A	Gutter Ponding?	N/A	N/A	Gutter Slope (%)	N/A
N/A	Gutter Lip Ht (in)	N/A	N/A	Gutter X Slope (%)	N/A
N/A	Painted X Walk1?	Yes	N/A	Painted X Walk2?	N/A
	X Walk 1 Direction	To NE		X Walk 2 Direction	N/A
N/A	X Walk 1 Width (in)	124.0	N/A	X Walk 2 Width (in)	N/A
	X Walk 1 Slope (%)	6.4		X Walk 2 Slope (%)	N/A
	X Walk 1 X Slope (%)	5.2		X Walk 2 X Slope (%)	N/A

N/A	Ramp inside XWalk1?	Yes	N/A	Ramp inside XWalk2?	N/A
	Road Slope (%)	N/A	N/A	Clear Space?	N/A
	Road X Slope (%)	N/A	N/A	Clear Space to XWalk (in)	N/A
N/A	Any Obstructions?	N/A	N/A	Storm Grate/Utility Hazard?	N/A
	Obstruction Type			Storm Grate/Utility Type	
		N/A			N/A
		Yes		Surface Condition? (G/P)	Good

Possible Solutions:

Remove & Replace Entire Ramp.
