# Access Compliance Report

## Public Rights-of-Way

### (Curb Ramps)

| Intersection ID: 16357 | Main Street: MONROE_RD | Cross Street: ROSS_MOORE_AV | Location: SE |

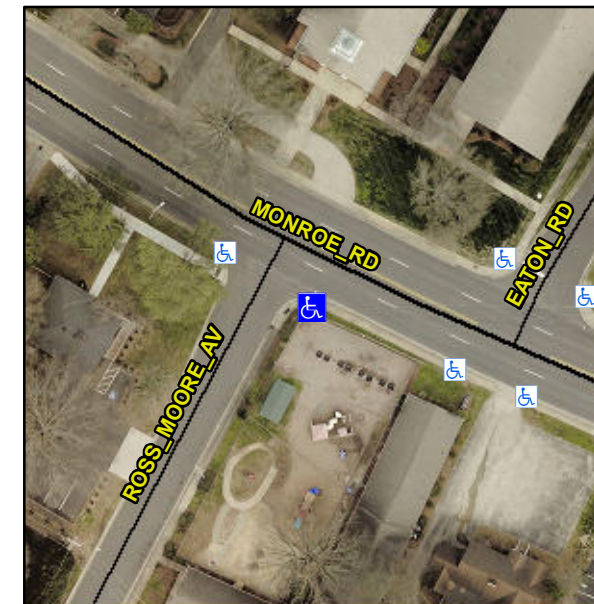
| ADA ID: 71D1C0B495FA | Ramp Type: BlendTrans1 | Initial Pass/Fail: Fail | Overall Compliance: No |
| Severity Score: 8.75 | | | |

**Not Found, R304.5.1**

| Compliance | Description | Data | Compliance | Description | Data |
|---|---|---|---|---|---|
| No | Ramp Width (in) | 47.0 | Yes | BlendTrans XSlope (%) | 1.3 |
| | | | No | Curb Slope (%) | 12.3 |

**Remove & Replace Curb Ramp With Two New Directional Ramps or Equivalent.**

Total Cost: \$ 3200.00
