# Access Compliance Report

## Public Rights-of-Way

### (Curb Ramps)

| Intersection ID: N/A | Main Street: ARBOR_LOOP_DR | Cross Street: POTOMAC_RIVER_PY | Location: E |

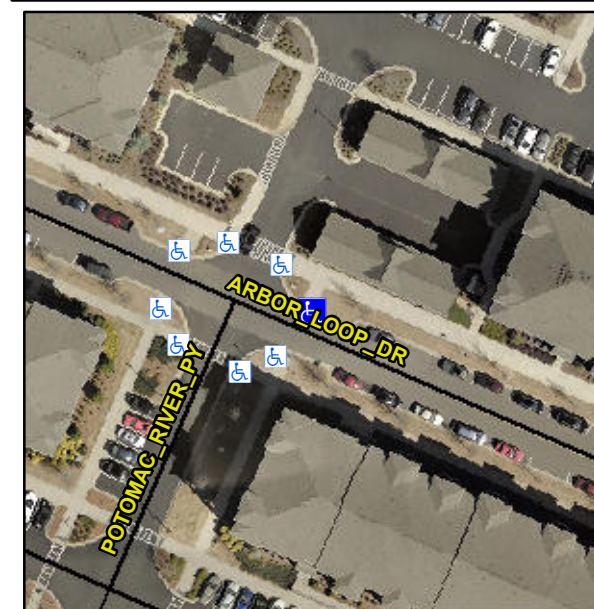
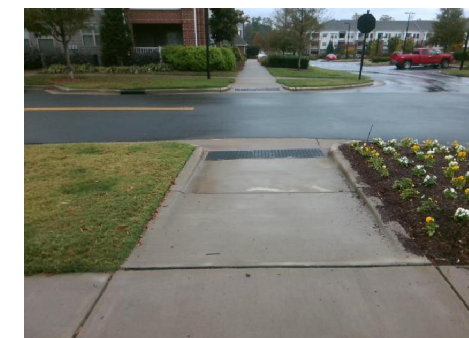
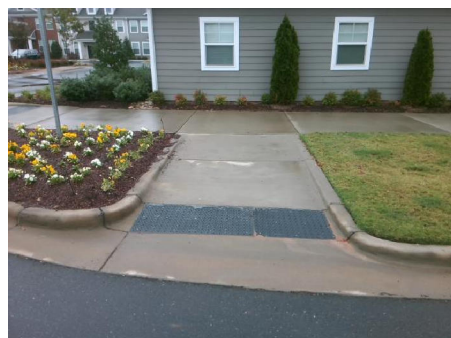
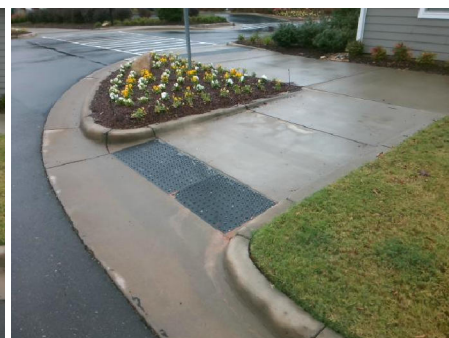
| Compliance | Description | Data | Compliance | Description | Data |
|---|---|---|---|---|---|
| N/A | Ramp Length (in) | 147.0 | Yes | Ramp Slope (%) | 6.7 |
| Yes | Ramp Width (in) | 81.0 | Yes | Ramp XSlope (%) | 2.0 |
| Yes | Flare Type L | Curbed_NoWalkSurface | Yes | Flare Type RT | N/A |
| Yes | Landing Length (in) | 119.0 | Yes | DWS Provided? | Yes |
| Yes | Gutter Ponding? | No | Yes | Gutter Slope (%) | 4.7 |
| Yes | Gutter Lip Ht (in) | 0.0 | Yes | Gutter X Slope (%) | 3.6 |
| | | | Yes | Surface Condition? (G/P) | Good |

**Remove & Replace Entire Ramp.**

Total Cost: \$ 1850.00
