Access Compliance Report

Public Rights-of-Way

(Curb Ramps)

Intersection ID: 16783	Main Street: HAMPTON_AV	Cross Street: MALVERN_RD	Location: NW
ADA ID: 71DF6AD10A94	Ramp Type: PerpDiag	Initial Pass/Fail: Fail	Overall Compliance: No
Severity Score: 22.5			
Codes/Mitigation Info/Possible Solution		Field Measurements/Component Compliance

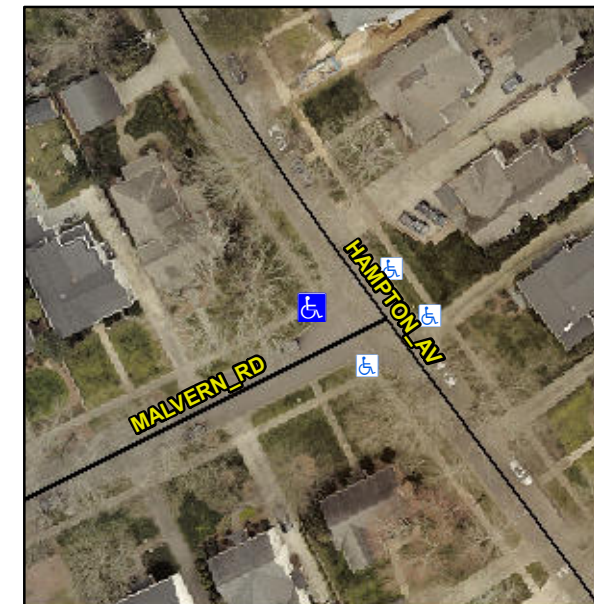
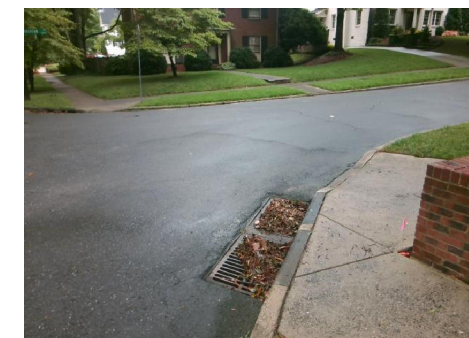
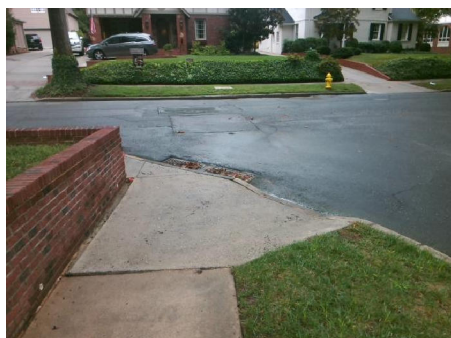
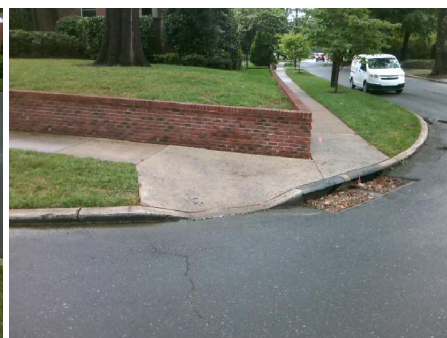
Compliance	Description	Data	Compliance	Description	Data
N/A	Ramp Length (in)	88.0	No	Ramp Slope (%)	8.9
No	Ramp Width (in)	41.0	No	Ramp XSlope (%)	3.8
N/A	Flare Type LT	N/A	N/A	Flare Type RT	N/A
N/A	Flare Slope LT (%)	N/A	N/A	Flare Slope RT (%)	N/A
N/A	Flare Traversable LT?	N/A	N/A	Flare Traversable RT?	N/A
N/A	Landing Length (in)	N/A	N/A	DWS Provided?	N/A
N/A	Landing Width (in)	N/A	N/A	DWS Contrast?	N/A
N/A	Landing Slope (%)	N/A	N/A	DWS Length (in)	N/A
N/A	Landing X Slope (%)	N/A	N/A	DWS Full Width?	N/A
N/A	Landing Curb? (Y/N)	N/A	N/A	DWS Offset (in)	N/A
N/A	Shared Landing?	N/A			
N/A	Gutter Ponding?	N/A	N/A	Gutter Slope (%)	N/A
N/A	Gutter Lip Ht (in)	N/A	N/A	Gutter X Slope (%)	N/A
N/A	Painted X Walk1?	No	N/A	Painted X Walk2?	No
	X Walk 1 Direction	To SE		X Walk 2 Direction	To E
N/A	X Walk 1 Width (in)	N/A	N/A	X Walk 2 Width (in)	N/A
	X Walk 1 Slope (%)	4.0		X Walk 2 Slope (%)	1.4
	X Walk 1 X Slope (%)	0.7		X Walk 2 X Slope (%)	4.1

N/A	Ramp inside XWalk1?	N/A	N/A	Ramp inside XWalk2?	N/A
	Road Slope (%)	3.8	N/A	Clear Space?	N/A
	Road X Slope (%)	6.5	N/A	Clear Space to XWalk (in)	N/A
N/A	Any Obstructions?	N/A	N/A	Storm Grate/Utility Hazard?	N/A
	Obstruction Type			Storm Grate/Utility Type	
		N/A			N/A
			Yes	Surface Condition? (G/P)	Good

Possible Solutions:

Remove & Replace Curb Ramp With Two New Directional Ramps or Equivalent.
