# Access Compliance Report

## Public Rights-of-Way

### (Curb Ramps)

| Intersection ID: 29820 | Main Street: PROVIDENCE_RD_WEST | Cross Street: WEDGEWOOD_COMMONS_DR | Location: N |

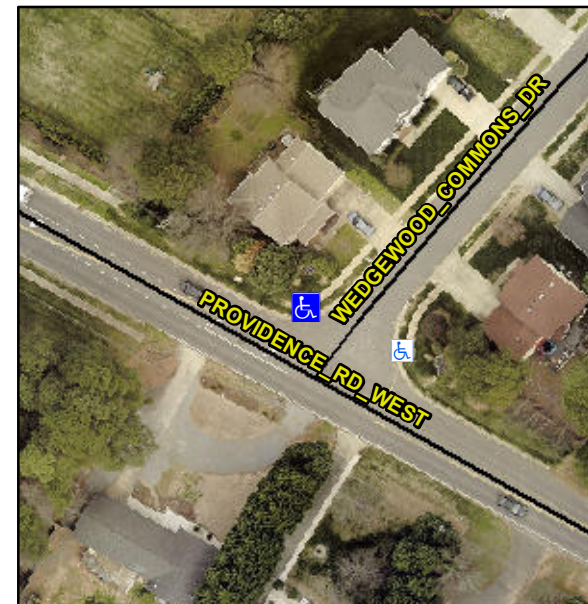
**Not Found, R304.5.1, R304.2.2, R304.5.3**

| Compliance | Description | Data | Compliance | Description | Data |
|---|---|---|---|---|---|
| N/A | Ramp Length (in) | 42.0 | No | Ramp Slope (%) | 8.4 |
| No | Ramp Width (in) | 46.0 | No | Ramp XSlope (%) | 3.1 |

**Remove & Replace Curb Ramp With Two New Directional Ramps or Equivalent.**
