Access Compliance Report Public Rights-of-Way (Curb Ramps)

Intersection ID: 46309	Main Street: BRIDLE_BROOK_WY	Cross Street: MERMANS_RD	Location: SW
ADA ID: 7200A8430C9E	Ramp Type: PerpDiag	Initial Pass/Fail: Fail	Overall Compliance: No Severity Score: 8.75

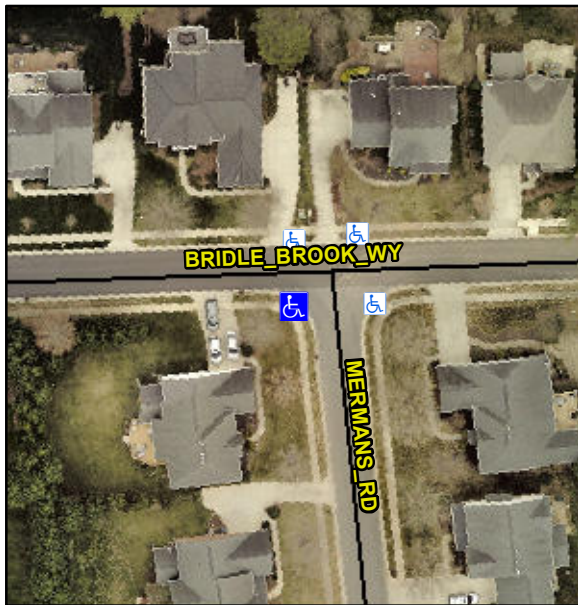
Not Found, R304.5.1

Compliance	Description	Data	Compliance	Description	Data
N/A	Ramp Length (in)	48.5	Yes	Ramp Slope (%)	5.0
No	Ramp Width (in)	44.5	Yes	Ramp XSlope (%)	0.4
N/A	Flare Type LT	N/A	N/A	Flare Type RT	N/A
N/A	Flare Slope LT (%)	N/A	N/A	Flare Slope RT (%)	N/A
N/A	Flare Traversable LT?	N/A	N/A	Flare Traversable RT?	N/A
N/A	Landing Length (in)	N/A	N/A	DWS Provided?	N/A
N/A	Landing Width (in)	N/A	N/A	DWS Contrast?	N/A
N/A	Landing Slope (%)	N/A	N/A	DWS Length (in)	N/A
N/A	Landing X Slope (%)	N/A	N/A	DWS Full Width?	N/A
N/A	Landing Curb? (Y/N)	N/A	N/A	DWS Offset (in)	N/A
N/A	Shared Landing?	N/A			
N/A	Gutter Ponding?	N/A	N/A	Gutter Slope (%)	N/A
N/A	Gutter Lip Ht (in)	N/A	N/A	Gutter X Slope (%)	N/A
N/A	Painted X Walk1?	No	N/A	Painted X Walk2?	No
	X Walk 1 Direction	To E		X Walk 2 Direction	To N
N/A	X Walk 1 Width (in)	N/A	N/A	X Walk 2 Width (in)	N/A
	X Walk 1 Slope (%)	1.9		X Walk 2 Slope (%)	0.4
	X Walk 1 X Slope (%)	0.4		X Walk 2 X Slope (%)	1.3

N/A	Ramp inside XWalk1?	N/A	N/A	Ramp inside XWalk2?	N/A
	Road Slope (%)	0.1	N/A	Clear Space?	N/A
	Road X Slope (%)	1.7	N/A	Clear Space to XWalk (in)	N/A
N/A	Any Obstructions?	N/A	N/A	Storm Grate/Utility Hazard?	N/A
	Obstruction Type			Storm Grate/Utility Type	
		N/A			N/A
			Yes	Surface Condition? (G/P)	Good

Remove & Replace Curb Ramp With Two New Directional Ramps or Equivalent.
