Access Compliance Report

Public Rights-of-Way

(Curb Ramps)

Intersection ID: 43172	Main Street: N_TRYON_ST	Cross Street: KEMP_ST	Location:	E
ADA ID: 7209A8669CF8	Ramp Type: Perp	Initial Pass/Fail: Fail	Overall Compliance: No	Severity Score: 10
Codes/Mitigation Info/Possible Solution		Field Measurements/Component Compliance

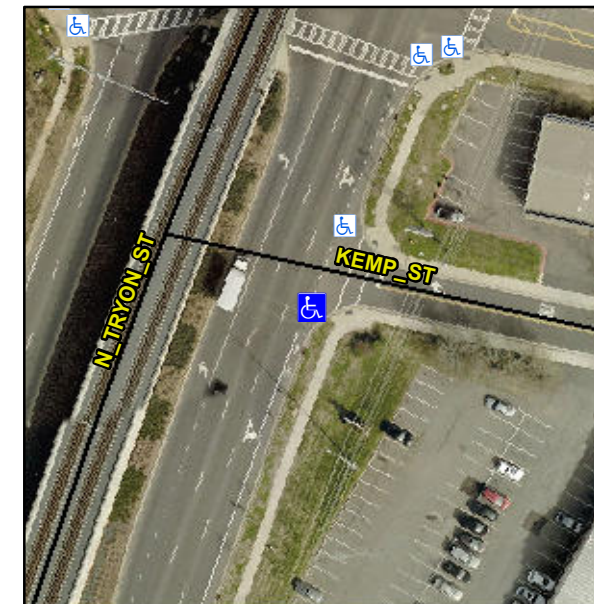
Not Found, R304.5.1, R304.5.3

Compliance	Description	Data	Compliance	Description	Data
N/A	Ramp Length (in)	71.0	Yes	Ramp Slope (%)	7.1
No	Ramp Width (in)	46.0	No	Ramp XSlope (%)	3.9
N/A	Flare Type LT	N/A	N/A	Flare Type RT	N/A
N/A	Flare Slope LT (%)	N/A	N/A	Flare Slope RT (%)	N/A
N/A	Flare Traversable LT?	N/A	N/A	Flare Traversable RT?	N/A
N/A	Landing Length (in)	N/A	N/A	DWS Provided?	N/A
N/A	Landing Width (in)	N/A	N/A	DWS Contrast?	N/A
N/A	Landing Slope (%)	N/A	N/A	DWS Length (in)	N/A
N/A	Landing X Slope (%)	N/A	N/A	DWS Full Width?	N/A
N/A	Landing Curb? (Y/N)	N/A	N/A	DWS Offset (in)	N/A
N/A	Shared Landing?	N/A			
N/A	Gutter Ponding?	N/A	N/A	Gutter Slope (%)	N/A
N/A	Gutter Lip Ht (in)	2.5	N/A	Gutter X Slope (%)	N/A
N/A	Painted X Walk1?	Yes	N/A	Painted X Walk2?	N/A
	X Walk 1 Direction	To NE		X Walk 2 Direction	N/A
N/A	X Walk 1 Width (in)	118.0	N/A	X Walk 2 Width (in)	N/A
	X Walk 1 Slope (%)	4.1		X Walk 2 Slope (%)	N/A
	X Walk 1 X Slope (%)	4.8		X Walk 2 X Slope (%)	N/A

N/A	Ramp inside XWalk1?	Yes	N/A	Ramp inside XWalk2?	N/A
	Road Slope (%)	N/A	N/A	Clear Space?	N/A
	Road X Slope (%)	N/A	N/A	Clear Space to XWalk (in)	N/A
N/A	Any Obstructions?	N/A	N/A	Storm Grate/Utility Hazard?	N/A
	Obstruction Type			Storm Grate/Utility Type	
		N/A			N/A
			Yes	Surface Condition? (G/P)	Good

Remove & Replace Entire Ramp.
