Access Compliance Report

Public Rights-of-Way

(Curb Ramps)

Intersection ID: 3237	Main Street: HERITAGE_HILLS_LN	Cross Street: MACKINAC_ST	Location: NE
ADA ID: 720B3AFA9BD5	Ramp Type: Directional1	Initial Pass/Fail: Fail	Overall Compliance: No
Severity Score: 12.5			
Codes/Mitigation Info/Possible Solution		Field Measurements/Component Compliance

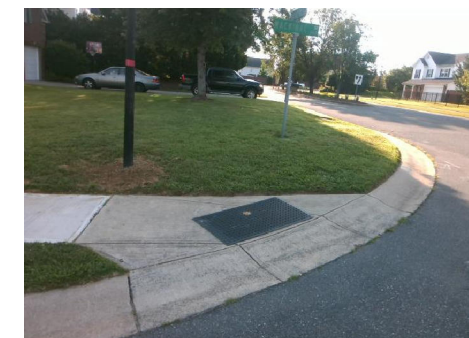
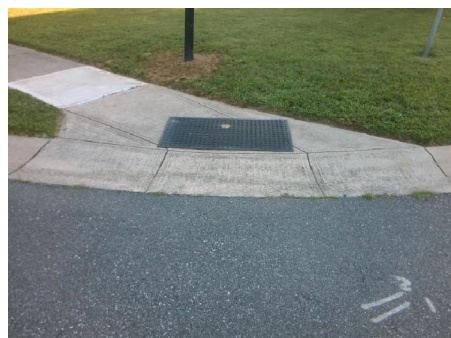
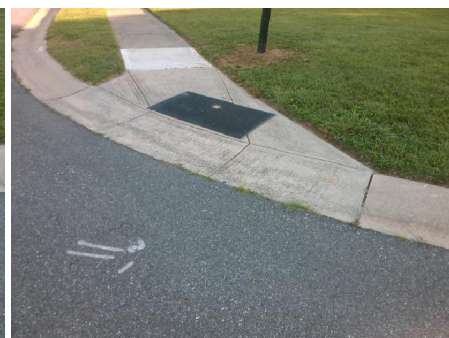
Compliance	Description	Data	Compliance	Description	Data
N/A	Ramp Length (in)	57.0	N/A	Grade Break?	N/A
Yes	Ramp Width (in)	48.0	N/A	Grade Break Slope (%)	0.0
Yes	Ramp Slope (%)	6.6	N/A	Grade Break XSlope (%)	0.0
No	Ramp XSlope (%)	6.0			
N/A	Flare Type LT	N/A	N/A	Flare Type RT	N/A
N/A	Flare Slope LT (%)	N/A	N/A	Flare Slope RT (%)	0.0
N/A	Flare Traversable LT?	N/A	N/A	Flare Traversable RT?	N/A
N/A	Landing Length (in)	0.0	N/A	DWS Provided?	N/A
N/A	Landing Width (in)	0.0	N/A	DWS Contrast?	N/A
N/A	Landing Slope (%)	0.0	N/A	DWS Length (in)	N/A
N/A	Landing X Slope (%)	0.0	N/A	DWS Full Width?	N/A
N/A	Landing Curb? (Y/N)	N/A	N/A	DWS Offset LT (in)	N/A
N/A	Shared Landing?	N/A	N/A	DWS Offset RT (in)	N/A
N/A	Gutter Ponding?	0.0	N/A	Gutter Slope (%)	N/A
N/A	Gutter Lip Ht (in)	0.0	N/A	Gutter X Slope (%)	N/A
N/A	Painted X Walk1?	No		Road Slope (%)	4.8
	X Walk 1 Direction	To S		Road X Slope (%)	3.6
	X Walk 1 Width (in)	N/A		Clear Space?	N/A

X Walk 1 Slope (%)	4.8	N/A	Clear Space to XWalk (in)	N/A
	X Walk 1 X Slope (%)	3.6	N/A	Storm Grate/Utility Hazard?	N/A
N/A	Ramp inside XWalk1?	N/A		Storm Grate/Utility Type	
N/A	Any Obstructions?	N/A			
	Obstruction Type		Yes	Surface Condition? (G/P)	Good
			N/A	Curb Slope (%)	N/A

Remove & Replace Entire Ramp.
