# Access Compliance Report

## Public Rights-of-Way

### (Curb Ramps)

Intersection ID: 12473	Main Street: S_CLARKSON_ST	Cross Street: W_PALMER_ST	Location:	N
ADA ID: 720EBBA2CB63	Ramp Type: PerpDiag	Initial Pass/Fail: Fail	Overall Compliance: No	Severity Score: 50
Codes/Mitigation Info/Possible Solution		Field Measurements/Component Compliance

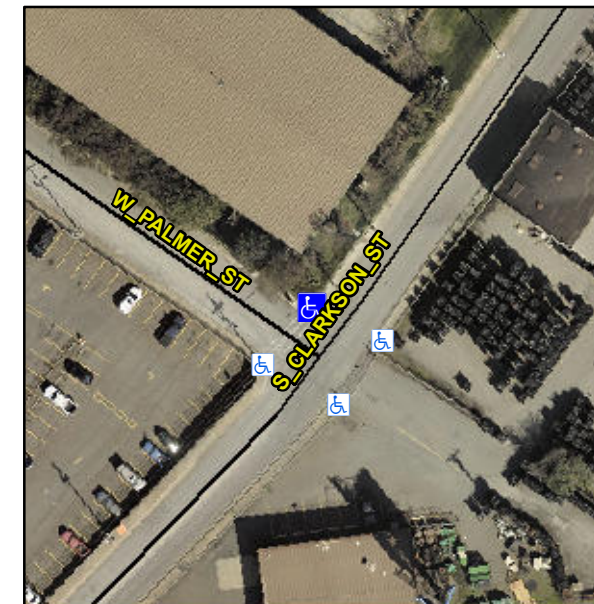
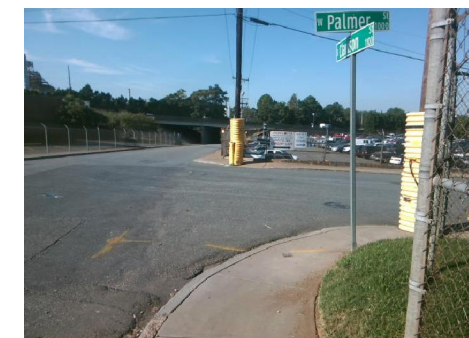
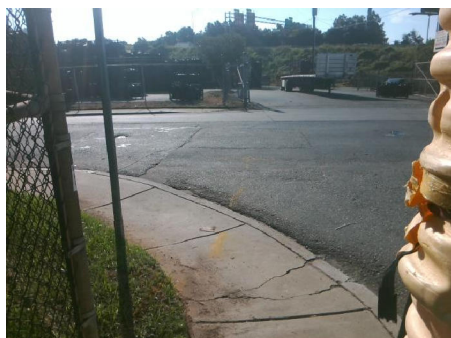
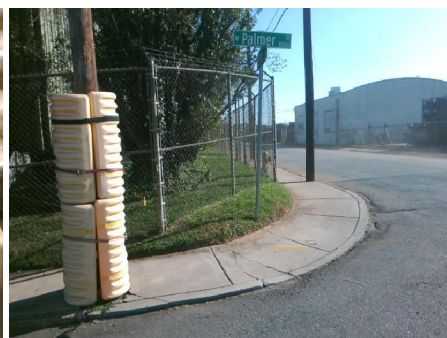
Compliance	Description	Data	Compliance	Description	Data
N/A	Ramp Length (in)	49.0	No	Ramp Slope (%)	14.8
Yes	Ramp Width (in)	72.0	No	Ramp XSlope (%)	11.7
N/A	Flare Type LT	N/A	N/A	Flare Type RT	N/A
N/A	Flare Slope LT (%)	N/A	N/A	Flare Slope RT (%)	N/A
N/A	Flare Traversable LT?	N/A	N/A	Flare Traversable RT?	N/A
N/A	Landing Length (in)	N/A	N/A	DWS Provided?	N/A
N/A	Landing Width (in)	N/A	N/A	DWS Contrast?	N/A
N/A	Landing Slope (%)	N/A	N/A	DWS Length (in)	N/A
N/A	Landing X Slope (%)	N/A	N/A	DWS Full Width?	N/A
N/A	Landing Curb? (Y/N)	N/A	N/A	DWS Offset (in)	N/A
N/A	Shared Landing?	N/A			
N/A	Gutter Ponding?	N/A	N/A	Gutter Slope (%)	N/A
N/A	Gutter Lip Ht (in)	N/A	N/A	Gutter X Slope (%)	N/A
N/A	Painted X Walk1?	No	N/A	Painted X Walk2?	No
	X Walk 1 Direction	To SW		X Walk 2 Direction	To SE
N/A	X Walk 1 Width (in)	N/A	N/A	X Walk 2 Width (in)	N/A
	X Walk 1 Slope (%)	3.0		X Walk 2 Slope (%)	8.1
	X Walk 1 X Slope (%)	7.7		X Walk 2 X Slope (%)	1.4

N/A	Ramp inside XWalk1?	N/A	N/A	Ramp inside XWalk2?	N/A
	Road Slope (%)	4.6	N/A	Clear Space?	N/A
	Road X Slope (%)	9.9	N/A	Clear Space to XWalk (in)	N/A
N/A	Any Obstructions?	N/A	N/A	Storm Grate/Utility Hazard?	N/A
	Obstruction Type			Storm Grate/Utility Type	
		N/A			N/A
			Yes	Surface Condition? (G/P)	Good

**Remove & Replace Curb Ramp With Two New Directional Ramps or Equivalent.**

**R304.2.2, R304.5.3**
