# Access Compliance Report

## Public Rights-of-Way

### (Curb Ramps)

| Intersection ID: 7131 | Main Street: N_TRYON_ST | Cross Street: ORCHARD_TRACE_LN | Location: SW |

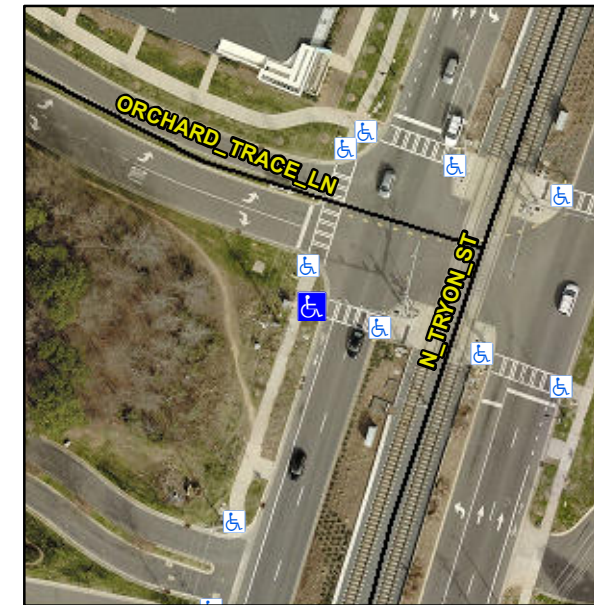
**Not Found, R305.2, R304.5.4**

| Compliance | Description | Data | Compliance | Description | Data |
|---|---|---|---|---|---|
| N/A | Landing Curb? (Y/N) | No | No | DWS Offset (in) | 3.0 |
| Yes | Gutter Ponding? | No | No | Gutter Slope (%) | 5.9 |
| | | | No | Curb Slope (%) | 7.8 |

**Remove & Replace Curb Ramp With Two New Directional Ramps or Equivalent. Remove & Replace Gutter.**

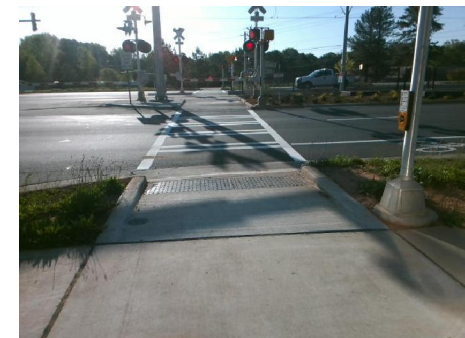
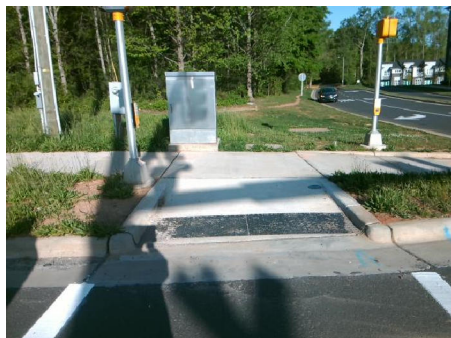
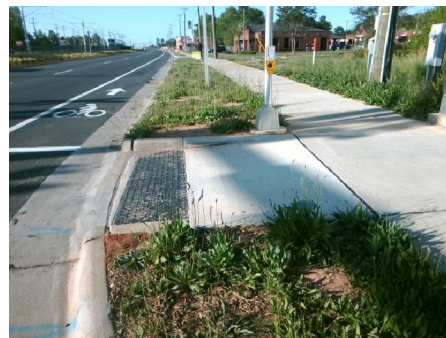
| ADA ID: 720F4AA02C81 | Ramp Type: BlendTrans1 | Initial Pass/Fail: Pass | Overall Compliance: No |
| | | Severity Score: 5 | |
