Access Compliance Report

Public Rights-of-Way

(Curb Ramps)

Intersection ID: 3033	Main Street: DEARMON_RD	Cross Street: BENFIELD RD	Location:	N
ADA ID: 72134939D1EF	Ramp Type: Perp	Initial Pass/Fail: Fail	Overall Compliance: No	Severity Score: 25
Codes/Mitigation Info/Possible Solution		Field Measurements/Component Compliance

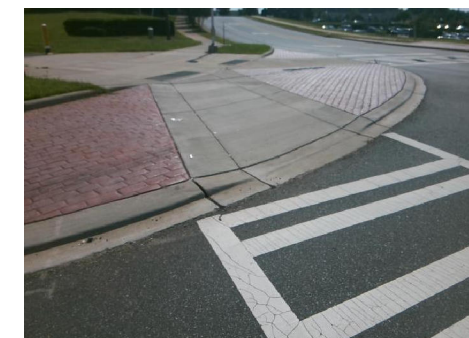
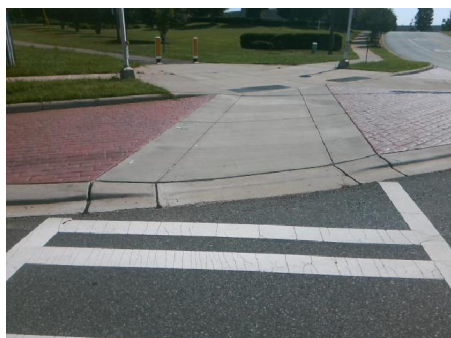
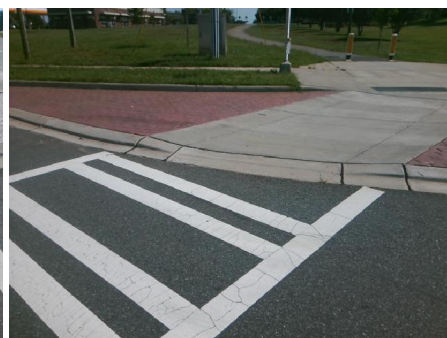
Compliance	Description	Data	Compliance	Description	Data
N/A	Ramp Length (in)	202.5	Yes	Ramp Slope (%)	19.4
Yes	Ramp Width (in)	55.5	Yes	Ramp XSlope (%)	0.6
N/A	Flare Type LT	N/A	N/A	Flare Type RT	N/A
N/A	Flare Slope LT (%)	N/A	N/A	Flare Slope RT (%)	N/A
N/A	Flare Traversable LT?	N/A	N/A	Flare Traversable RT?	N/A
N/A	Landing Length (in)	N/A	N/A	DWS Provided?	N/A
N/A	Landing Width (in)	N/A	N/A	DWS Contrast?	N/A
N/A	Landing Slope (%)	N/A	N/A	DWS Length (in)	N/A
N/A	Landing X Slope (%)	N/A	N/A	DWS Full Width?	N/A
N/A	Landing Curb? (Y/N)	N/A	N/A	DWS Offset (in)	N/A
N/A	Shared Landing?	N/A			
N/A	Gutter Ponding?	N/A	N/A	Gutter Slope (%)	N/A
N/A	Gutter Lip Ht (in)	N/A	N/A	Gutter X Slope (%)	N/A
N/A	Painted X Walk1?	Yes	N/A	Painted X Walk2?	N/A
	X Walk 1 Direction	To SW		X Walk 2 Direction	N/A
N/A	X Walk 1 Width (in)	111.5	N/A	X Walk 2 Width (in)	N/A
	X Walk 1 Slope (%)	3.3		X Walk 2 Slope (%)	N/A
	X Walk 1 X Slope (%)	0.1		X Walk 2 X Slope (%)	N/A

N/A	Ramp inside XWalk1?	No	N/A	Ramp inside XWalk2?	N/A
	Road Slope (%)	N/A	N/A	Clear Space?	N/A
	Road X Slope (%)	N/A	N/A	Clear Space to XWalk (in)	N/A
N/A	Any Obstructions?	N/A	N/A	Storm Grate/Utility Hazard?	N/A
	Obstruction Type			Storm Grate/Utility Type	
		N/A			N/A
			Yes	Surface Condition? (G/P)	Good

**Remove & Replace Entire Ramp.
Restripe Crosswalk.**
